Northumberland Road Protected Bike Lanes, Pascoe Vale

Road Safety Audit

Audit Stage: Post Construction

Kent Road Protected Bike Lanes, Pascoe Vale

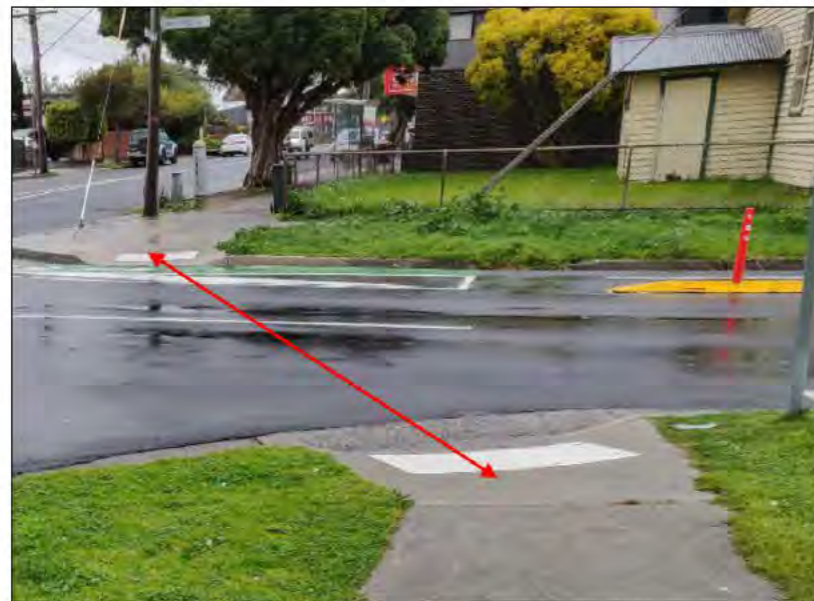
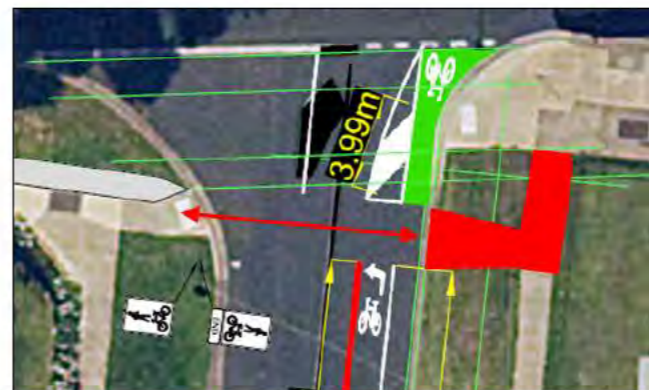
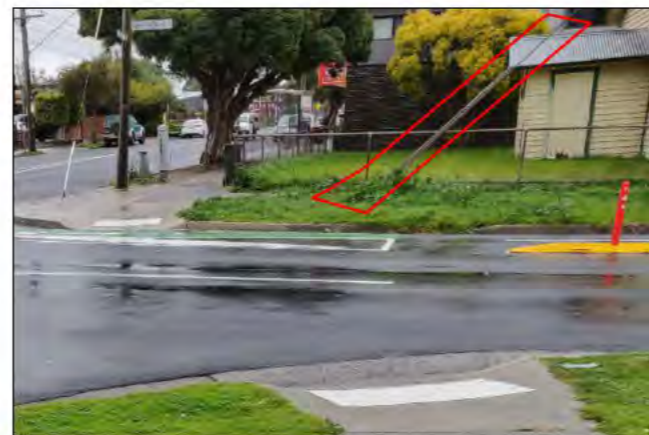
a) Pedestrian Crossings					
<p>i. The finding stated in the previous Concept Design RSA (produced by SSS, 18/01/21) still stands regarding the crossing on Northumberland Road near the Rhodes Parade intersection. The crossing is staggered, and pedestrians are required to cross at an angle. This is not the most direct (shortest) travel path for pedestrians to take and increases their time on the road. Additionally, it is not safe for pedestrians with vision impairments as they are being directed towards the main road, which may lead to pedestrian and vehicle collisions.</p>

Improbable Minor Low	Within tolerable limits	<p>Consider relocating the kerb ramp further south to align with the ramp on the west. (S)</p> <p>It is noted that there is a utility pole support cable that may impact the relocation of the kerb ramp.</p>

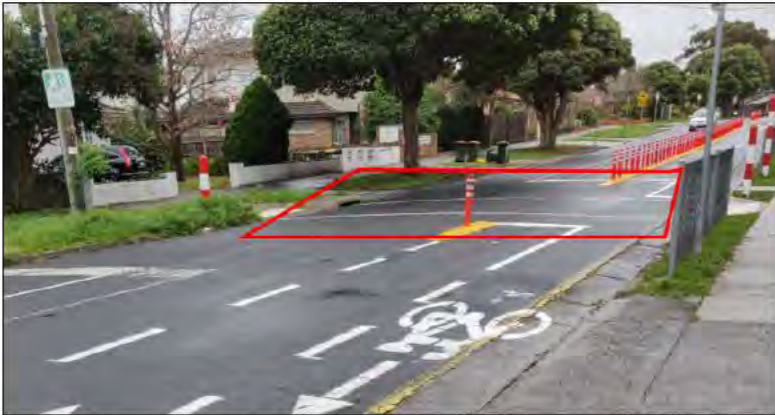
Audit Findings	Level of Risk	Safe System Energy	Recommendations P – Primary ST – Step Towards S – Supporting N – Non-Safe System	Responsible Officer	
				Accept Yes/No	Comments
ii. The main mid-block crossing that connects pedestrians to the Pascoe Vale Girls College on Northumberland Road does not stand-out with the additional new infrastructure installed. Motorists may not identify the crossing and travel through the crossing at an inappropriate speed leading to pedestrian and vehicle conflicts.

Occasional Minor Medium	Within tolerable limits	Consider raising the pedestrian crossing to reduce speed and to provide a defined pedestrian crossing. (S)

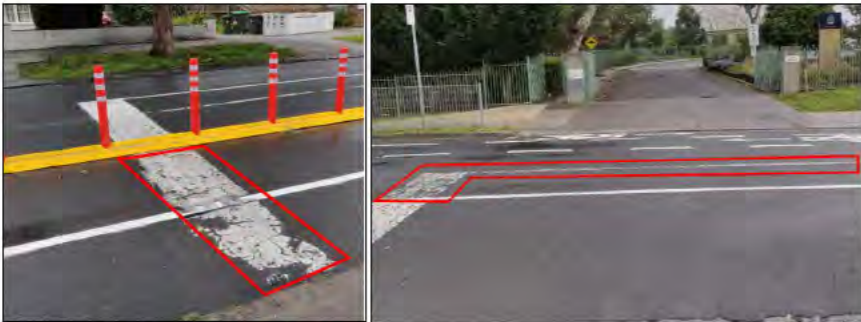
b) Pavement Markings					
i. The auditor noted redundant linemarking was evident on the carriageway and within the bi-directional bike lanes at the following locations, which may lead to confusion on the network: <ul style="list-style-type: none"> - <u>Around the mid-block school crossing on Northumberland Road</u>

Occasional Minor Medium	Within tolerable limits	Consider complete removal of the redundant linemarking by blacking out the markings or grinding off the linemarking. (S)

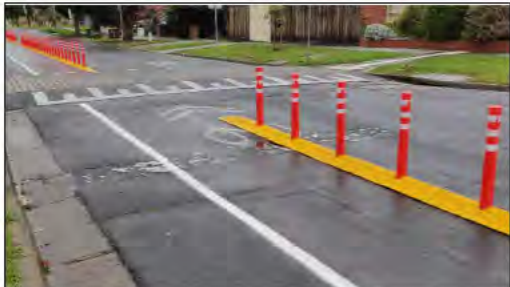
<ul style="list-style-type: none"> - <u>Prior to the raised pedestrian crossing, near the Crowley intersection</u>

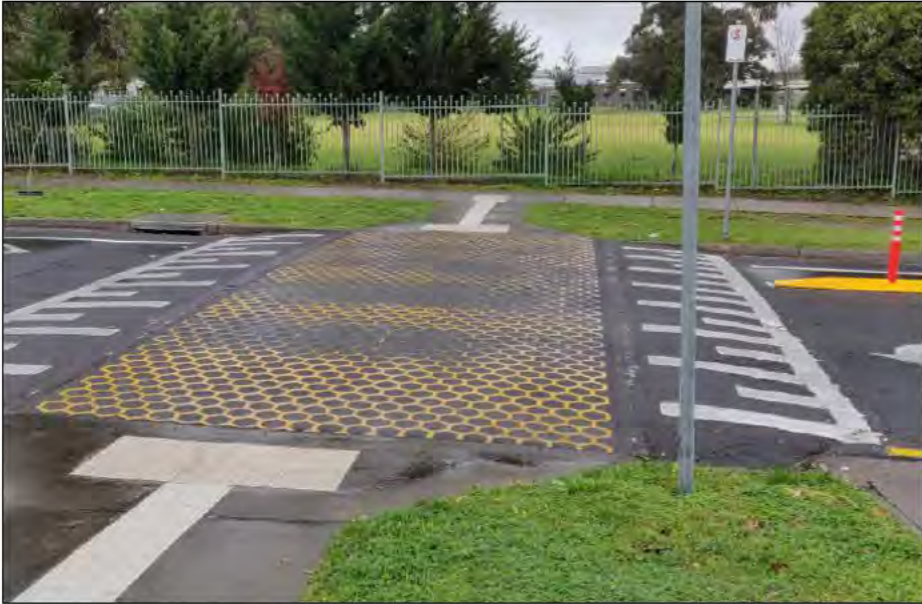
Audit Findings	Level of Risk	Safe System Energy	Recommendations P – Primary ST – Step Towards S – Supporting N – Non-Safe System	Responsible Officer	
				Accept Yes/No	Comments
ii. The stencilled linemarkings on top of the raised pedestrian crossing is faded in sections that align with continuous vehicle track marks.

To Note	-	Consider reinstating the faded stencilling and ensure on-going maintenance so the pedestrian crossing is clearly defined on the network. (S)		
iii. The finding stated in the previous Concept Design RSA (produced by SSS, 18/01/21) still stands regarding the entrance to Pascoe Vale Girls College. The entrance crosses the protected bike lane, which creates a conflict point between vehicles and cyclists. This is emphasised by the undulating road environment.

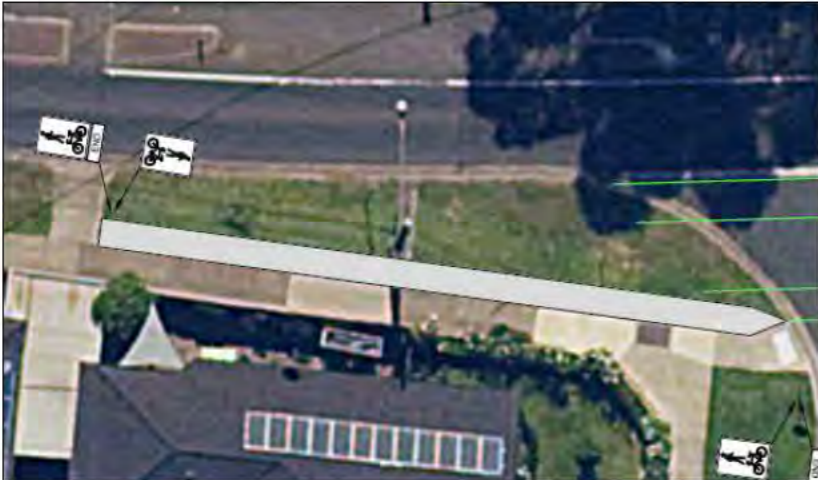
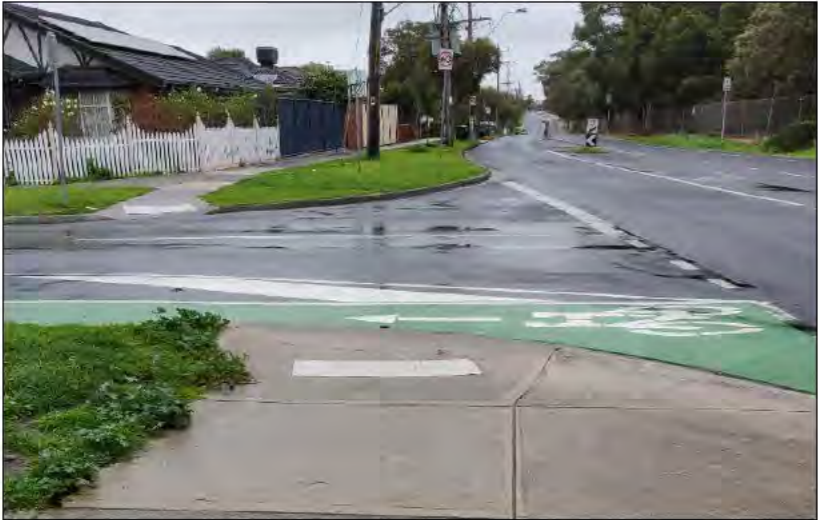
c) Functionality					
<p>i. The design proposed to extend the width of the existing footpath on the south/west side of the Rhodes Parade intersection. This is so the footpath can be upgraded to a shared use path so the new facility can connect to the existing SUP network, to the north of Rhodes Parade. The path has not been widened, which means the new facility ends without providing a safe connection to the existing SUP network, this may lead to confusion and potential conflicts with pedestrians should cyclists use the existing footpath to safely access the SUP.</p>

Occasional Minor Medium	Within tolerable limits	<p>Consider widening the footpath, so that cyclists can safely connect to the existing SUP network. (S)</p> <p>It is noted that existing power pole utilities may impact the widening of the footpath.</p>

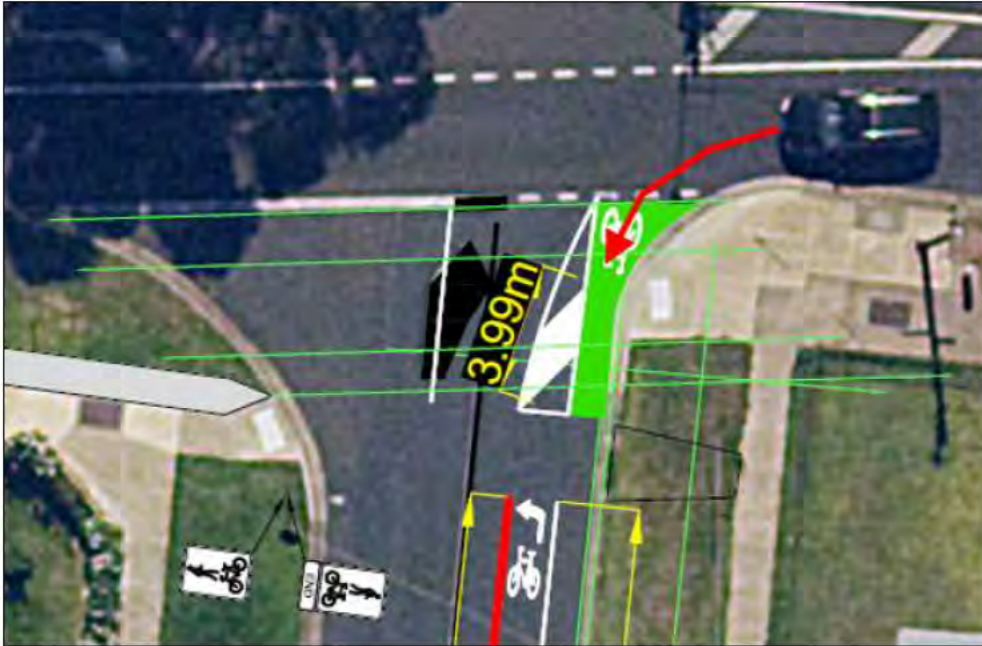
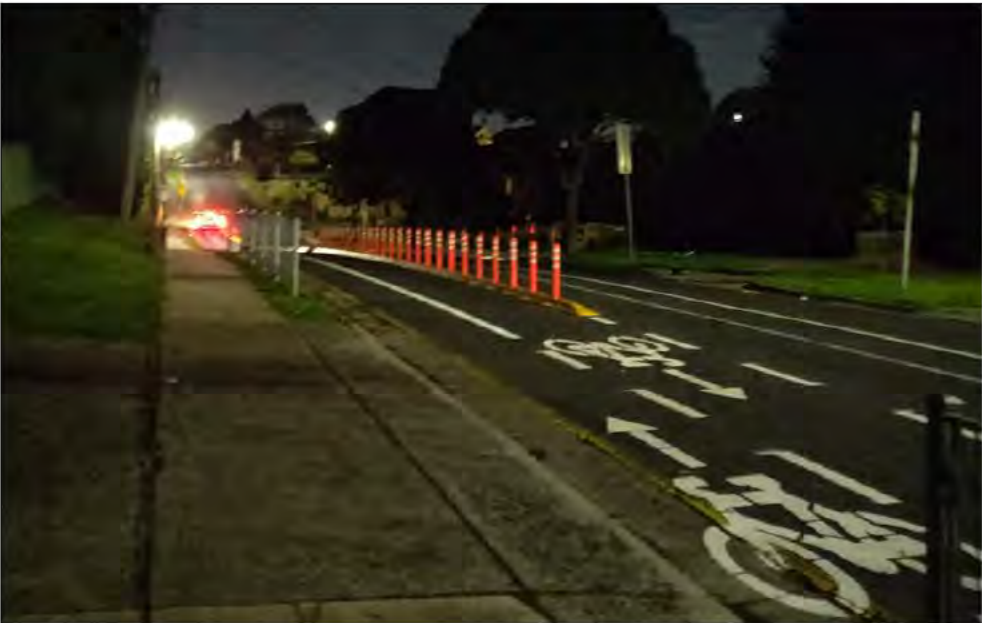
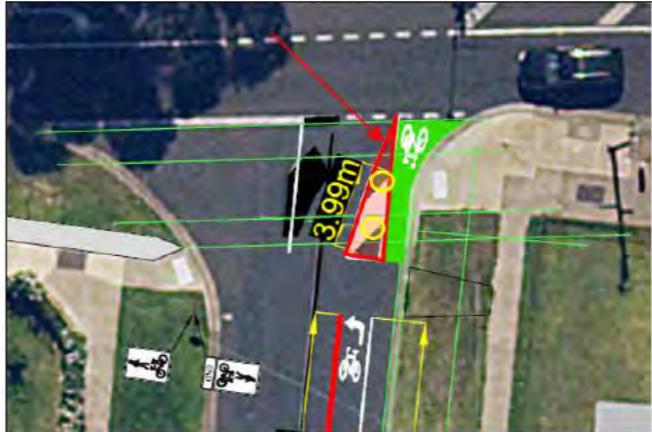
Audit Findings	Level of Risk	Safe System Energy	Recommendations P – Primary ST – Step Towards S – Supporting N – Non-Safe System	Responsible Officer	
				Accept Yes/No	Comments
<p>ii. The auditor observed a vehicle within the bi-directional bike lane travelling southbound during the night audit. It is assumed the motorist entered the separated bike lane by turning left from Pascoe Street into Northumberland. This is a high-risk safety issue that could lead to a serious crash type between a vehicle and cyclists.</p>

<p>Occasional Serious High</p>	<p>Above tolerable limits (important)</p>	<p>Consider implementing a treatment at the entrance to the separated cycle lane at the Rhodes Parade intersection to ensure vehicles cannot physically enter the separated bike lane. A temporary bolt-down kerb with flexible bollards shown in the mark-up below could be investigated. (S)</p>

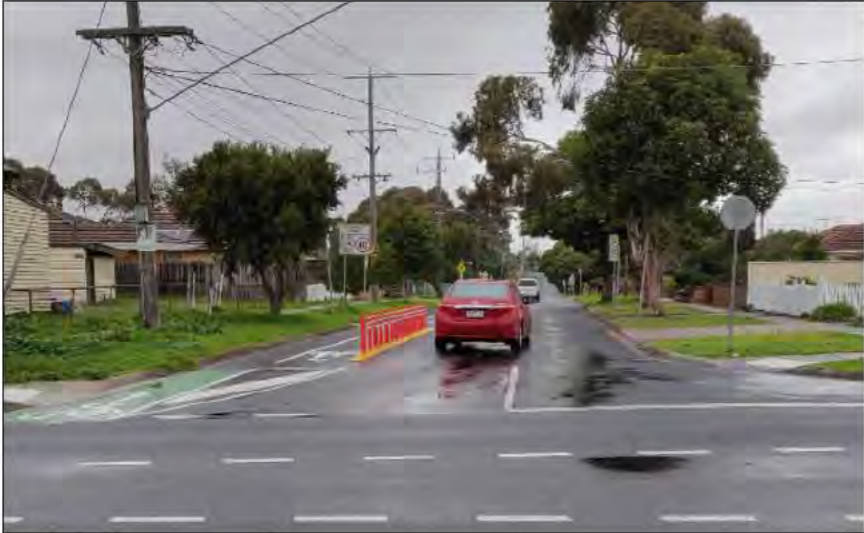
Audit Findings	Level of Risk	Safe System Energy	Recommendations P – Primary ST – Step Towards S – Supporting N – Non-Safe System	Responsible Officer	
				Accept Yes/No	Comments
<p>iii. The implementation of the separated bicycle lane has subsequently reduced the width of the northbound and southbound traffic lanes. The auditor observed motorists travelling into the opposite traffic lane due to the width constraints. This was evident throughout the whole section of Northumberland where the separated facility has been installed. This may lead to vehicle/ vehicle conflicts, especially where vehicles are turning onto Northumberland Road from side roads.</p>

Occasional Minor Medium	Within tolerable limits	Consider reducing the default 50km/h speed limit and monitor the performance of the treatment considering all road users. (P)		
<p>iv. Where the separated bike lane transitions from the road to the path at the south end of Northumberland Road, the turning circles appear tight for a cyclist to turn from the road to the path and the same for a cyclist turning onto the on-road facility from the path. This may lead to cyclist/ cyclist conflicts.</p>

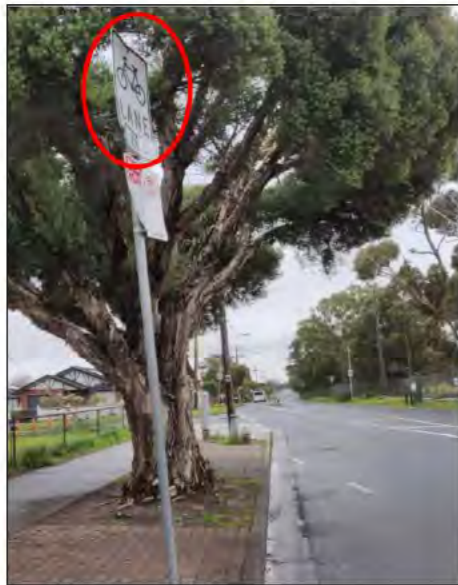
Audit Findings	Level of Risk	Safe System Energy	Recommendations P – Primary ST – Step Towards S – Supporting N – Non-Safe System	Responsible Officer	
				Accept Yes/No	Comments
d) Signage					
<div>i. The ‘End Bike Lane’ sign on Pascoe Street to the east of the Northumberland Road intersection is not facing the on-road bicycle lane.</div> <div>

</div>	To Note	-	Ensure the ‘End Bike Lane’ sign is facing the direction of the on-road cycle lane. Consider installing the sign on its own separate pole for clarity. (S)		
e) Temporary Bollards					
<div>i. The auditor noted that the reflective tape on some of the bollards throughout Northumberland Road have peeled away from the bollards.</div> <div>

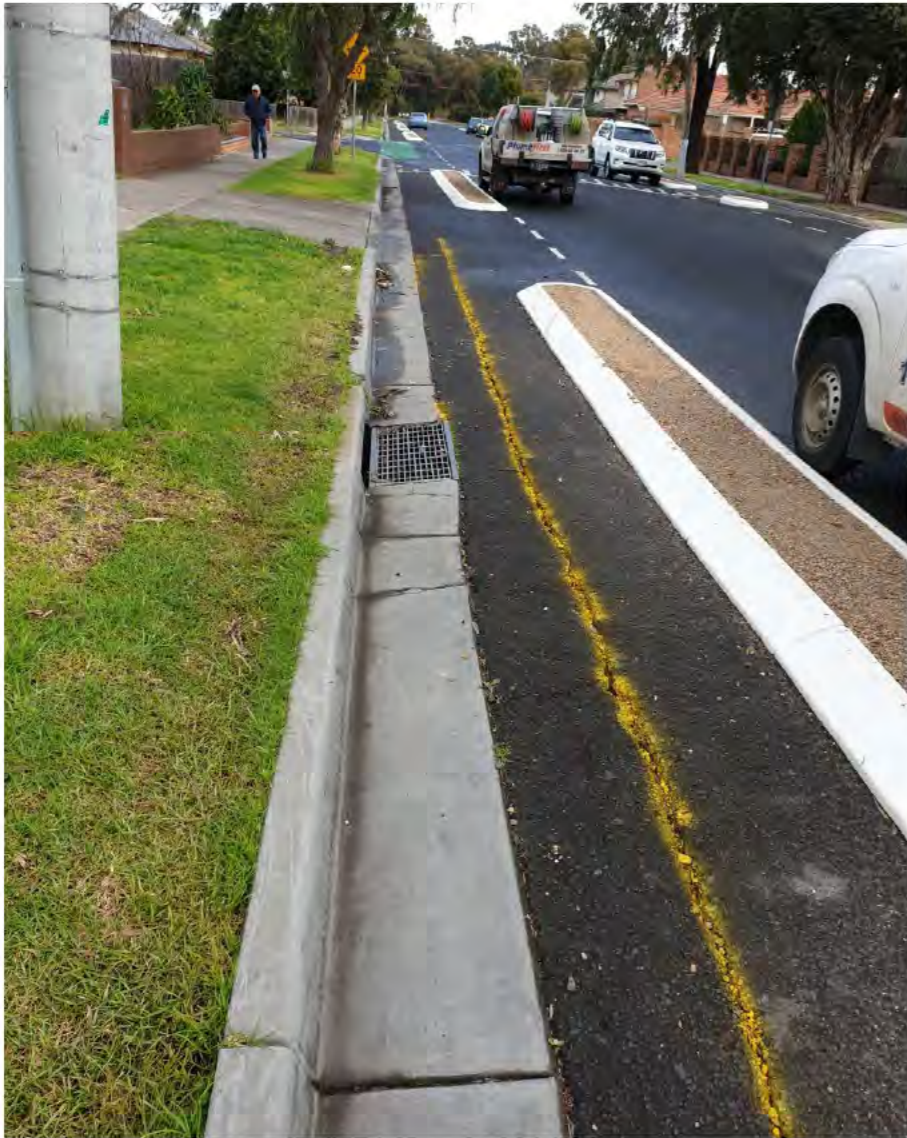
Audit Findings	Level of Risk	Safe System Energy	Recommendations P – Primary ST – Step Towards S – Supporting N – Non-Safe System	Responsible Officer	
				Accept Yes/No	Comments
a) Cycle path issues					
<p>i) On the westbound bicycle path just east of Valerie St, there is a longitudinal groove on the path surface that may be hazardous to cyclists. Narrow bicycle wheels can get caught and tramline in this groove.</p> <p>It appears to already have been identified as a hazard and highlighted with some yellow paint.</p>

Probable Minor HIGH	Within tolerable limits	Consider resurfacing the path to remove these grooves (S)

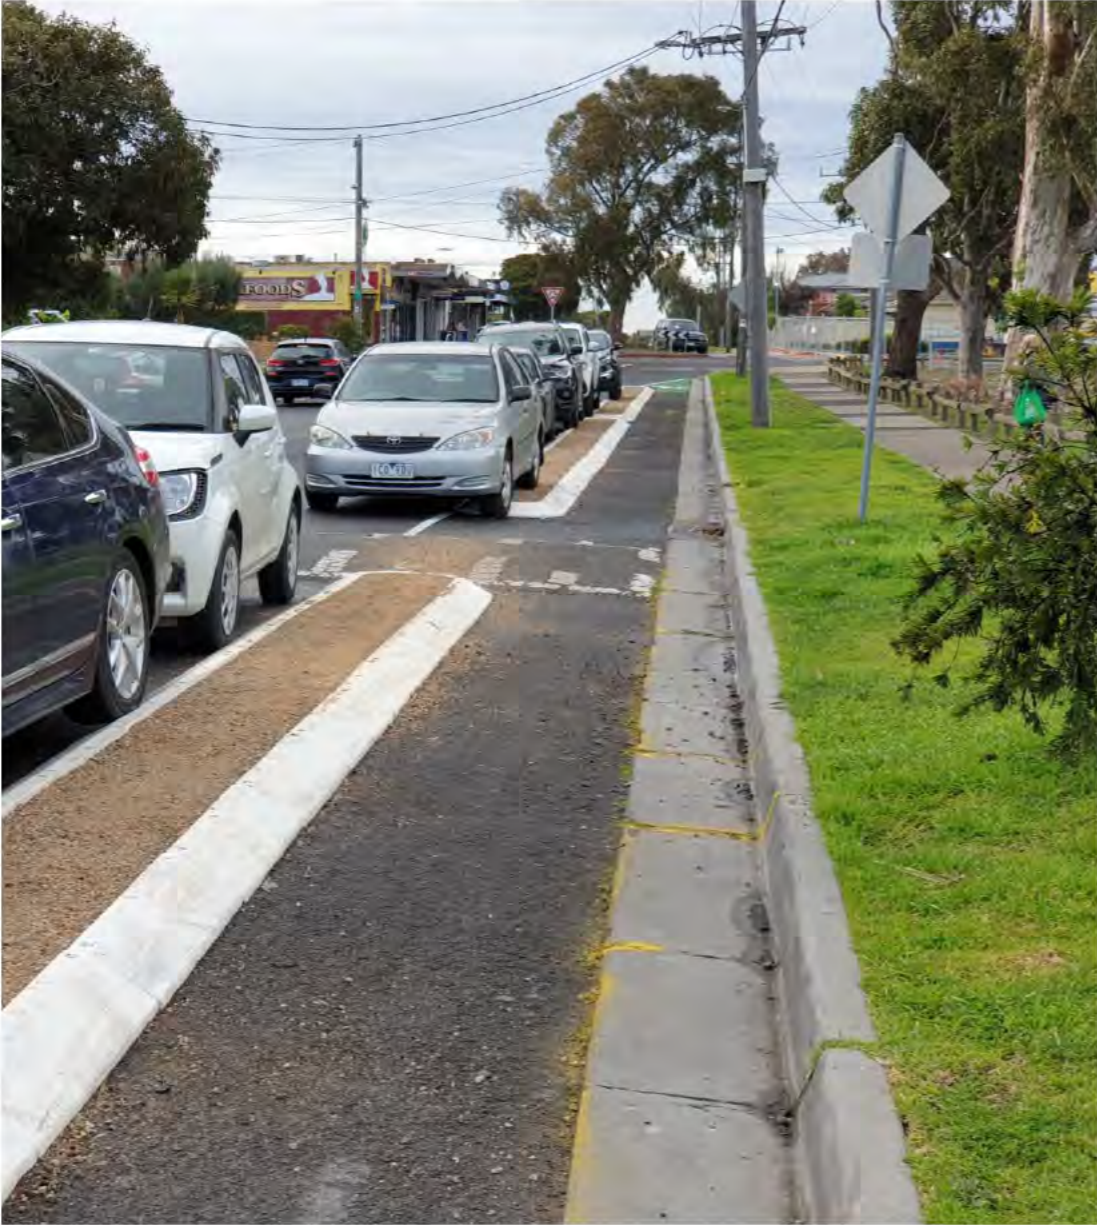
Audit Findings	Level of Risk	Safe System Energy	Recommendations P – Primary ST – Step Towards S – Supporting N – Non-Safe System	Responsible Officer	
				Accept Yes/No	Comments
<p>ii) Cycle paths are formed kerbside by the installation of a 1.0m wide temporary separator, positioned to provide approx. 1.2m cycle path width between kerb and separator. However the kerb channel forms part of this path width.</p> <p>The join between the channel lip and asphalt road/path forms a level change or a groove that may trap narrow bicycle tyres and may be hazardous to cyclists. This may be exacerbated over time as the asphalt and concrete parts of the path settle and form step changes in the surface.</p>

Occasional Minor MEDIUM	Within tolerable limits	If space permits, consider widening the path to min 1.2m excluding the drainage channel, so that cyclists are less likely to contact this groove. (S)

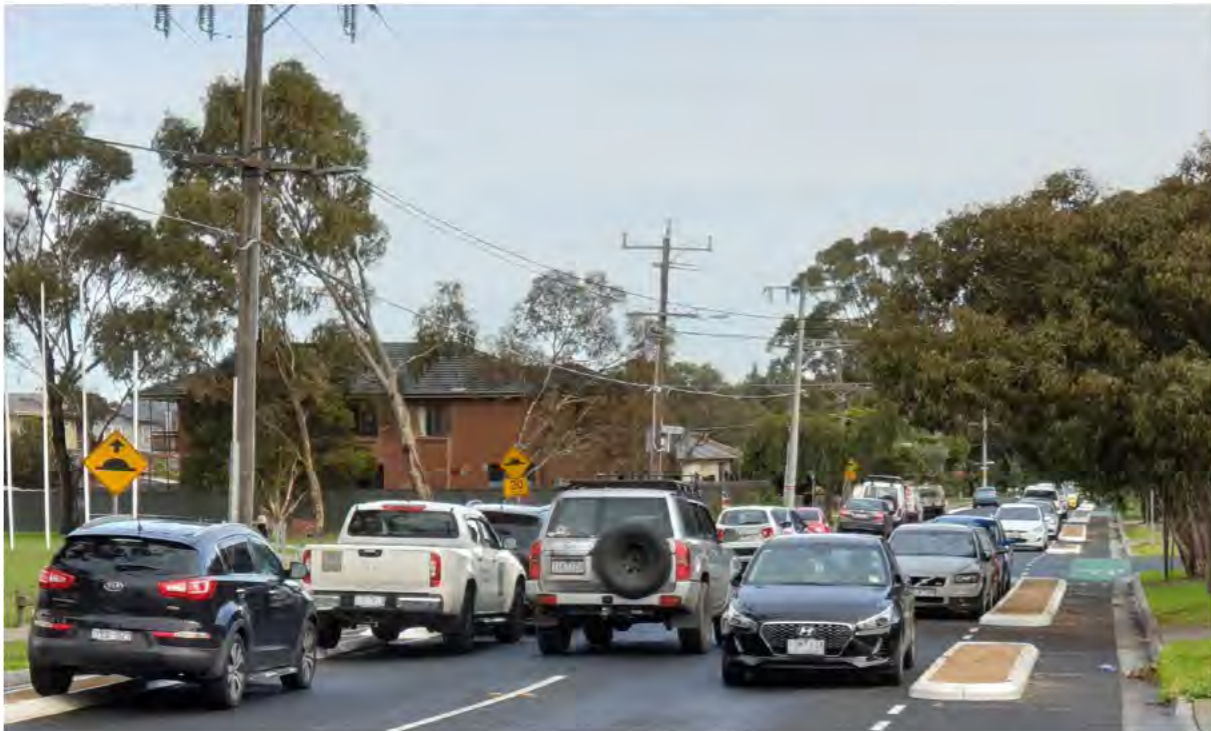
b) Roadway width					
<p>The trafficable roadway width has been reduced due to the provision of the new cycle paths. Previously, the width of Kent Road accessible to motor vehicles was sufficient for vehicles four abreast (two parked kerbside plus two concurrent traffic lanes). Two-way traffic were not required to take turns to pass.</p> <p>Post the installation of the protected cycle paths, the residual roadway width is in the vicinity of 7.5m wide. Where cars are parked on both sides (as is the case in areas of high parking demand), two-way traffic must take turns to pass, as illustrated in the photo below.</p>

<p>While this method of traffic operation is not inherently unsafe, a hazard may arise when the habitual behaviour of local drivers overrides any recognition of the new traffic layout. Drivers who are used to driving this street without having to take turns with oncoming traffic can experience cognitive dissonance and fail to perceive the risks when approaching another vehicle. As a result, they may also fail to take the appropriate evasive action. This is usually followed by a collision and much blaming of third parties, which are typical outcomes from driver cognitive dissonance.</p> <p>The risk outlined above is highest immediately after changes are implemented, and decay as drivers recognise that change has occurred and get used to the new layout.</p>	Occasional Minor MEDIUM	Within tolerable limits	Consider temporary signage to bring to the attention of all drivers that road conditions have changed. (S) An example sign is shown below.

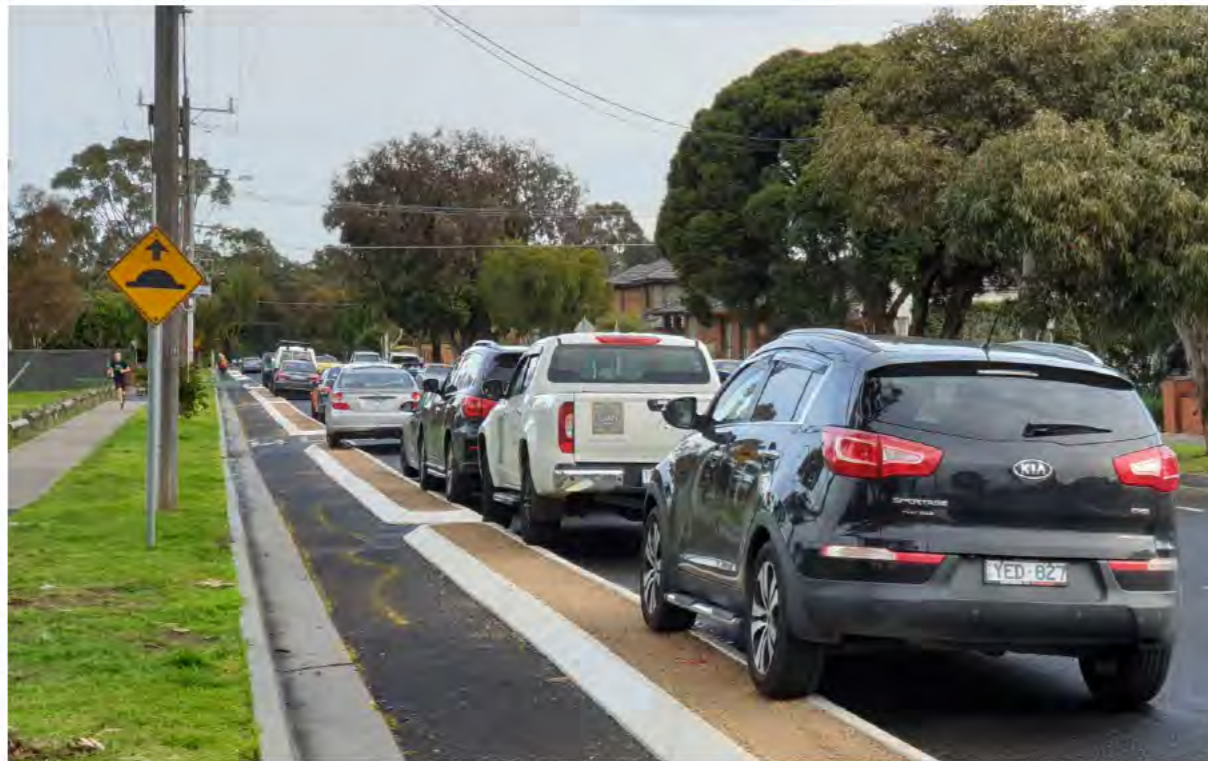
c) Parking					
<p>i) At the time of the daytime site visit, several cars were observed to have parked one wheel up on the temporary separators on the south side of Kent Road. This appears to be related to the use of semi-mountable kerb for this separator as this effect was not observed on the north side of Kent Road where a more upright barrier kerb design is used.</p> <p>Cars parking on the separators may be a hazard because:</p> <ol style="list-style-type: none"> 1. there is reduced buffer space between the parked car and the cycle path, which increases the risk of car dooring to cyclists. 2. Parking movements may be erratic as vehicles mount the kerb and may be harder to control. 	Improbable Minor LOW	Within tolerable limits	Consider replacing the mountable kerb separators with barrier kerb (S) Consider installing flexible bollards on the kerb separators. (S)
