Kent Road, Pascoe Vale

Road Safety Audit

Audit Stage: Post-completion

DOCUMENT NUMBER: S20220433-REP-001-Av01-RSA Kent Rd Pascoe Vale

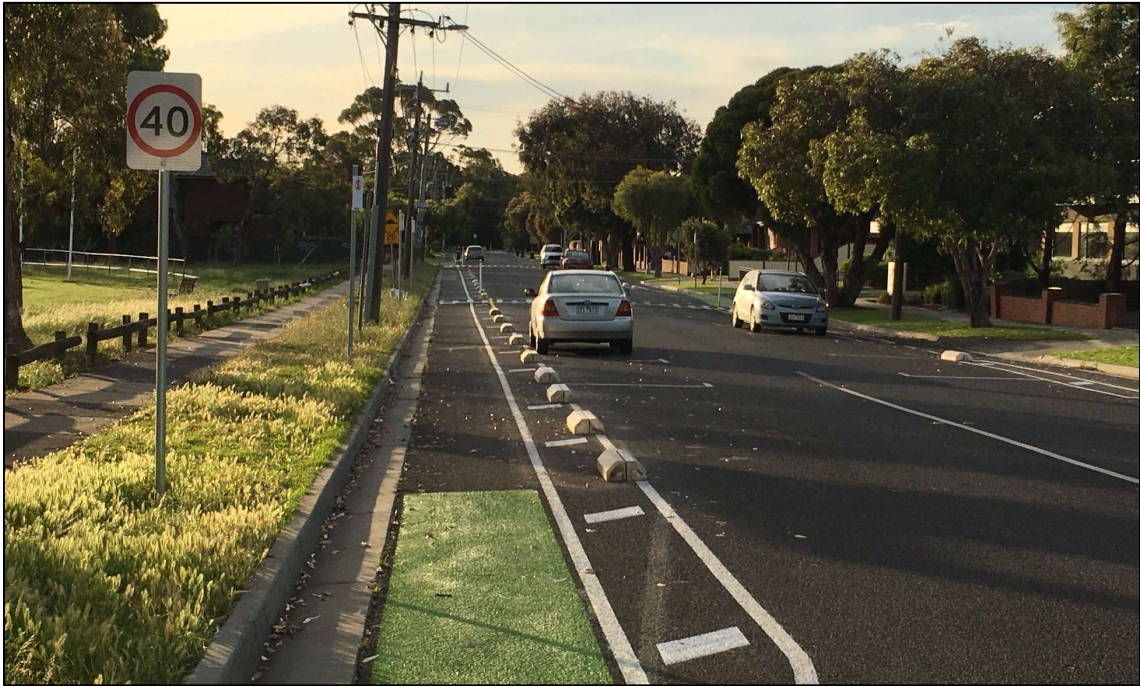
Photo 1: Entrance to Kent Road from Cumberland Road. Looking west

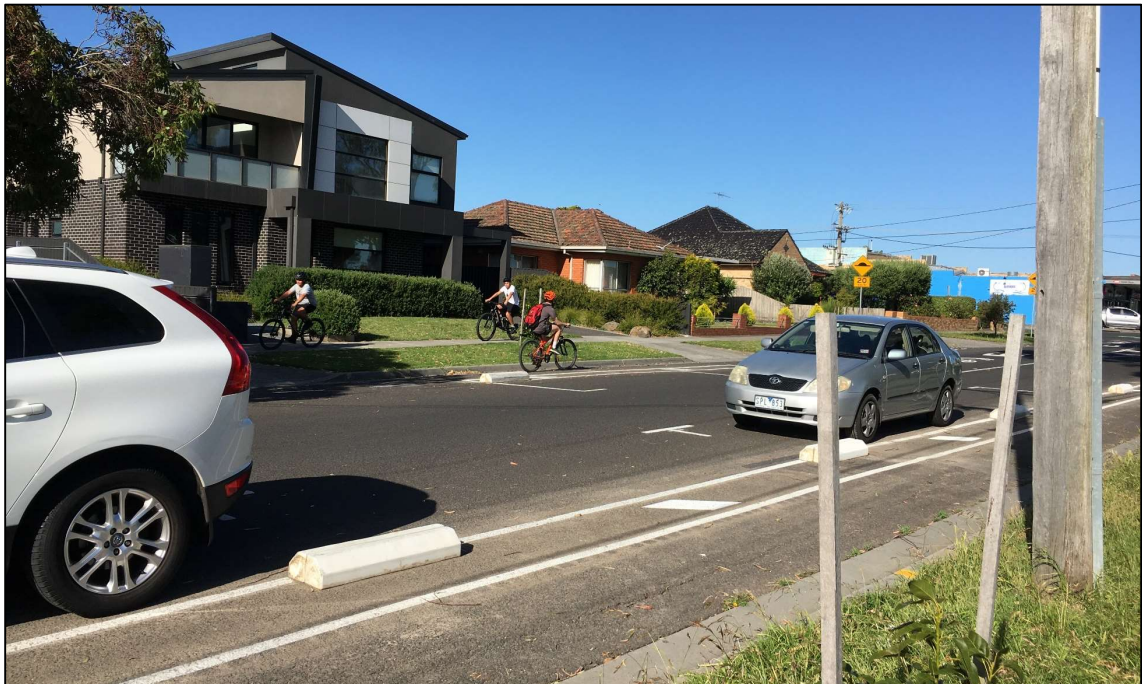
Photo 2: Bicycle users using the path. Note that some still use the footpath

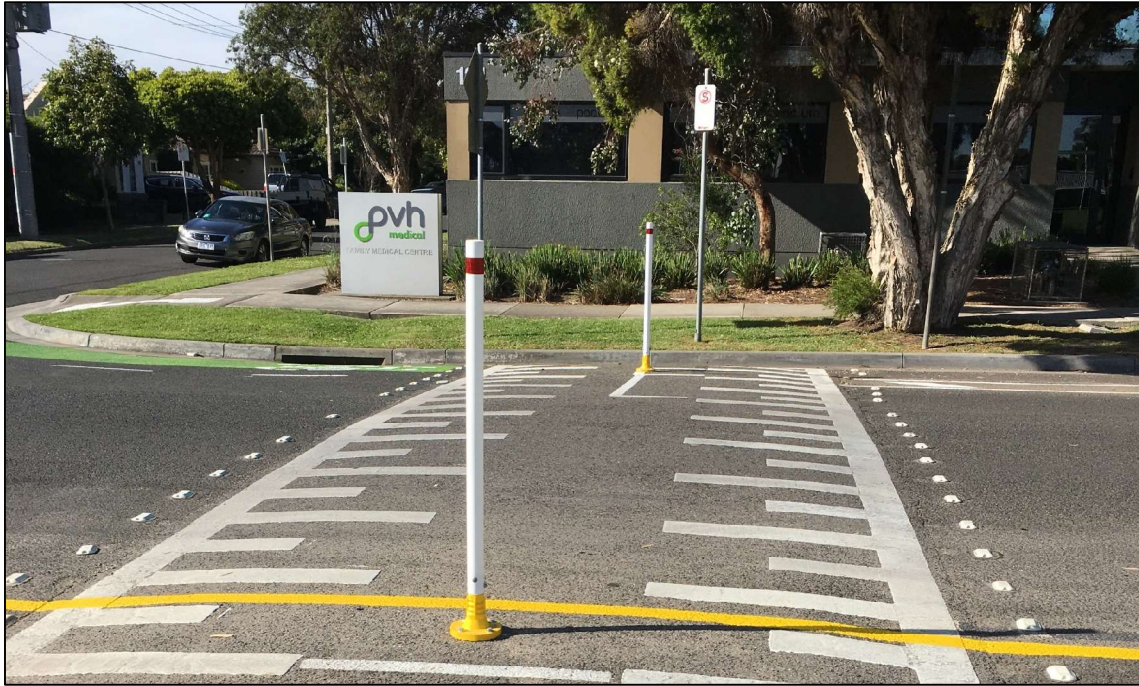
Photo 3: The first speed hump near Joffre Road showing line marking and bollards

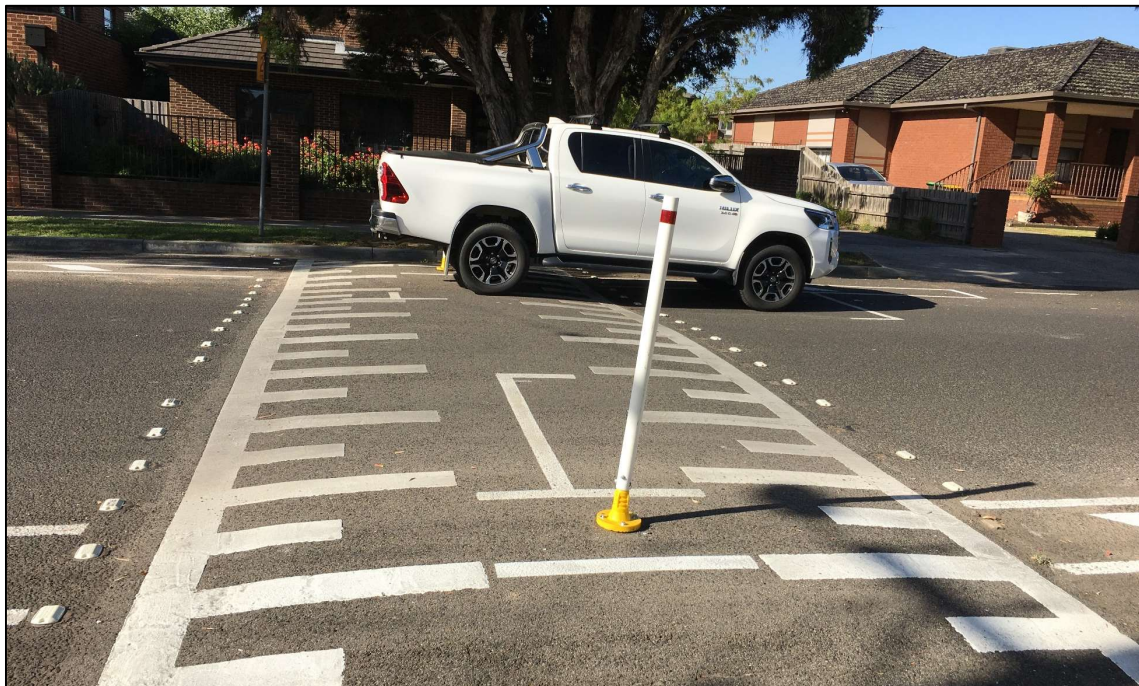
Photo 4: Second speed hump close to Valerie Street. Parking bays are painted onto the hump

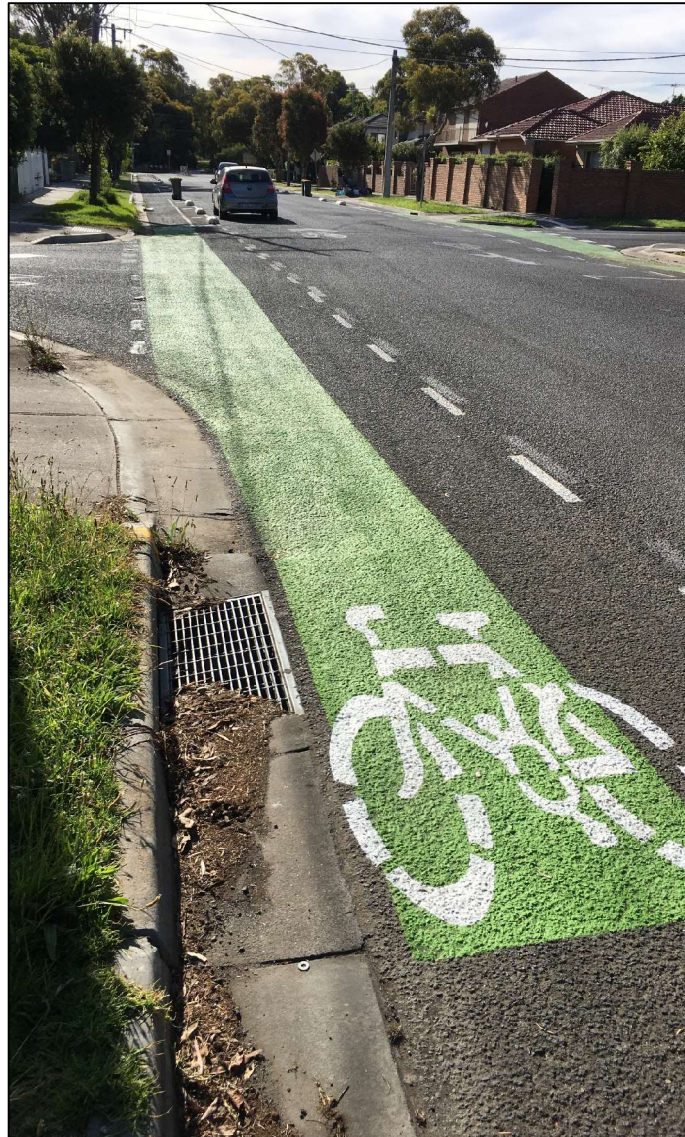
Photo 5: Green markings give warning for Bicycle path users and vehicles exiting from Valerie Street

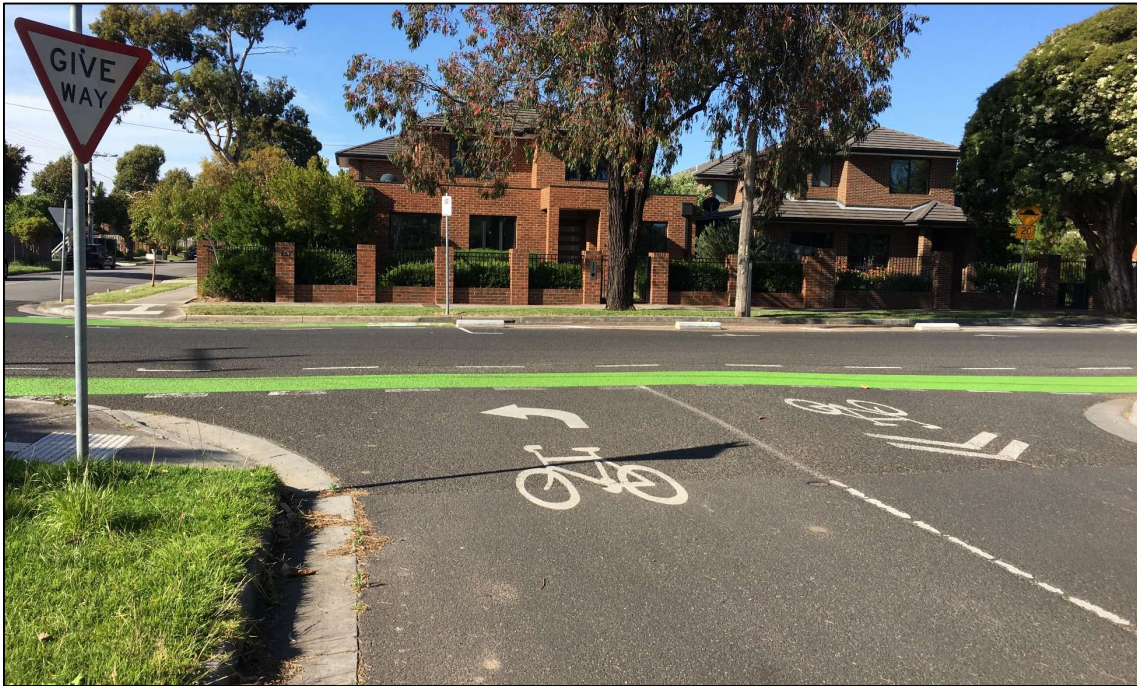
Photo 6: Exit from Valerie Street to Kent Rd. The left arrow is for the cyclists

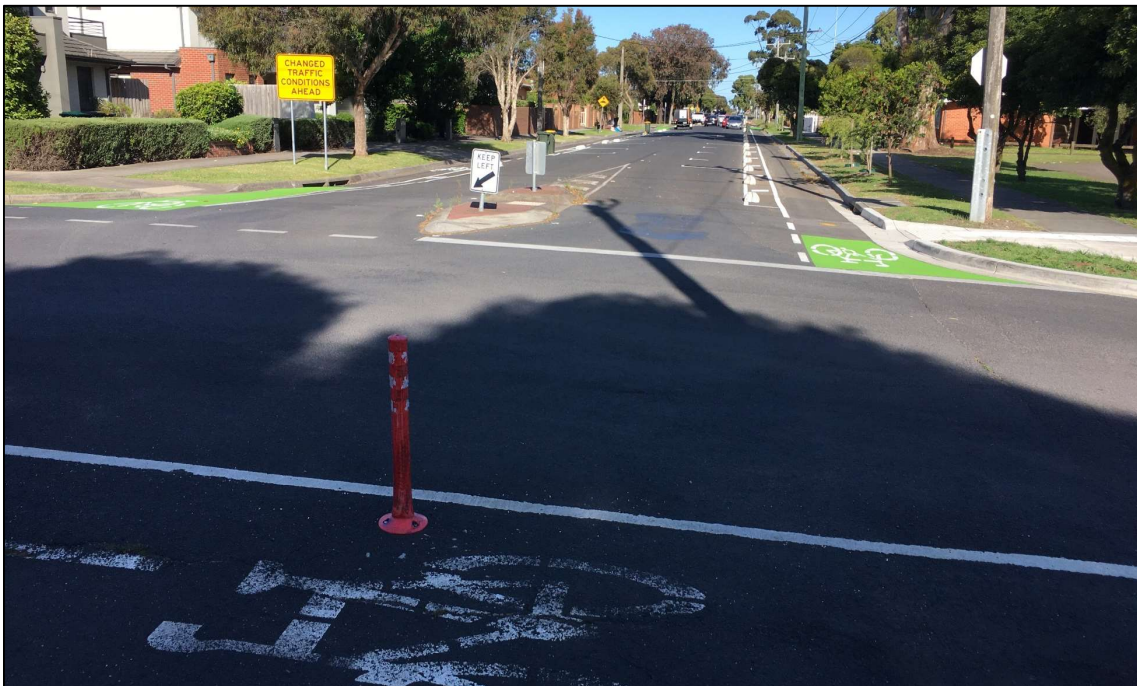
Photo 7: Intersection of Kent Road and Cornwall Road looking east

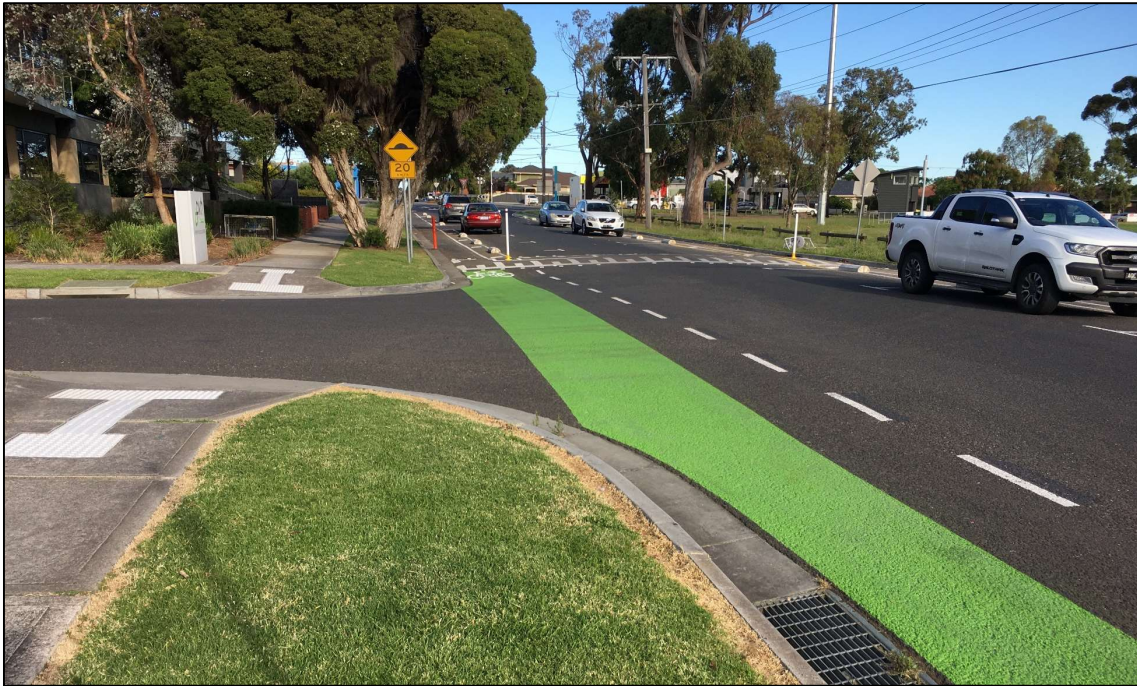
Photo 8: Intersection of Joffre Road and Kent Road. Medical centre on corner

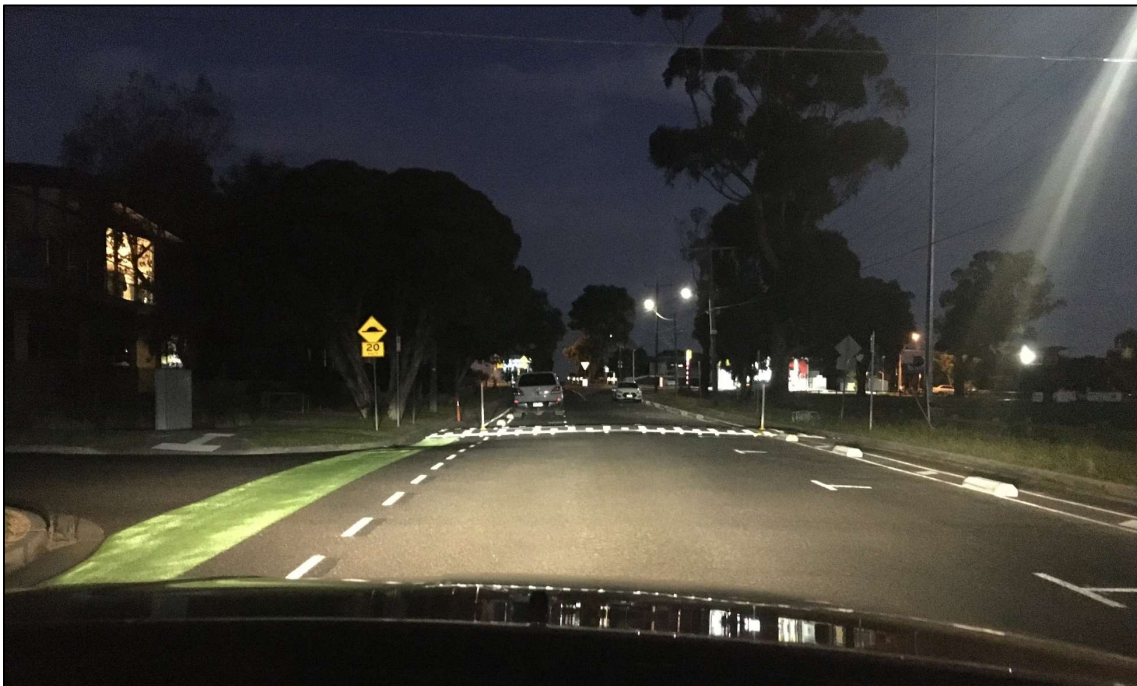
Photo 9: Retro Reflective markers help define the speed hump

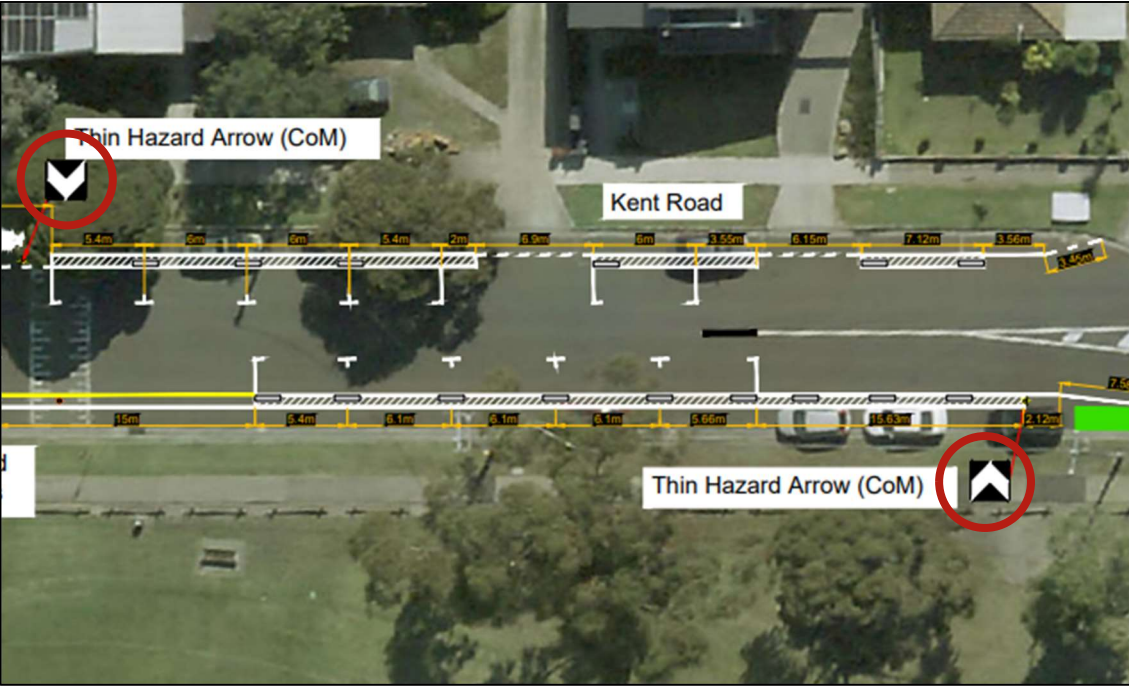
| Audit Findings | Risk Assessment | | | Recommendations<br><br>P – Primary<br>S – Supporting      ST – Step Towards<br>N – Non-Safe System | Responsible Officer | |
|---|---|---|---|---|---|---|
| <p>1. Hazard Marker signs not added yet. The design shows these signs to be placed on Kent Rd at east of Joffre Road, west of Cumberland Road, west of Valerie Street, east of Kitchener Road and east of Cornwall. There are 5 signs in total. These signs were not installed as of 20<sup>th</sup> December 2022 and should be installed as soon as possible to avoid vehicles exiting from side streets from entering the bike lane.</p> | Rare | Moderate | <b>Low</b><br><br>Safe System energy within tolerable levels | Consider installation of the signs (S) | Y | Signs have been ordered but they are a speciality, non-standard sign and take longer to fabricate. Signs will be installd as soon as they arrive. |

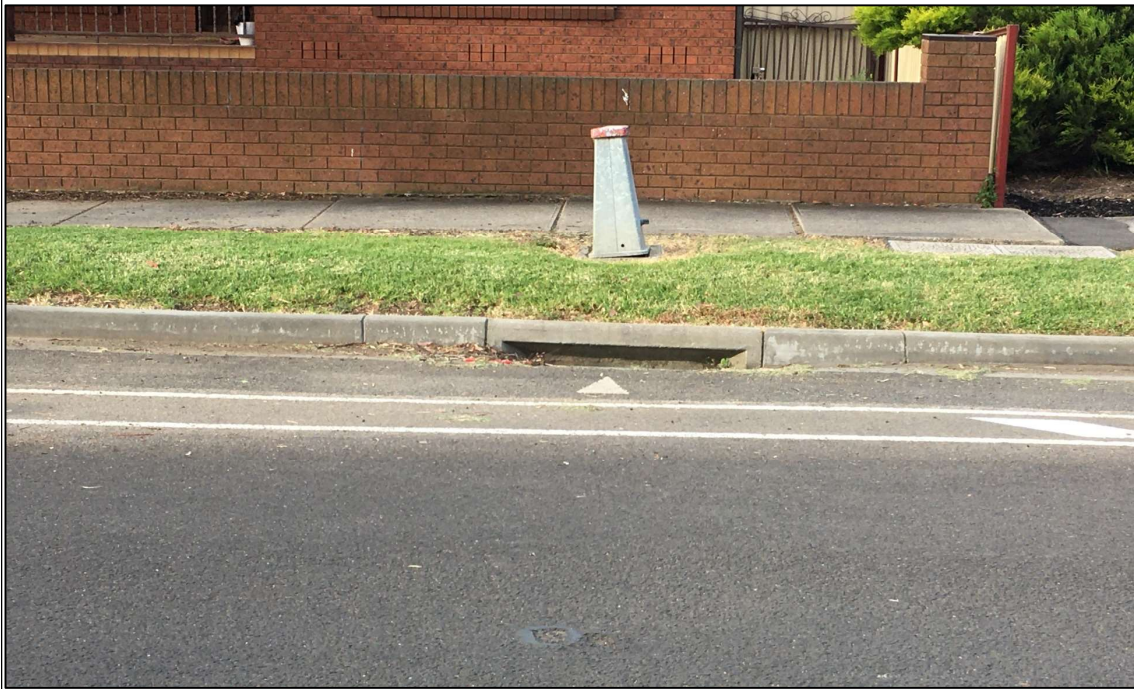
| Audit Findings | Risk Assessment | | | Recommendations<br><br>P – Primary<br>S – Supporting      ST – Step Towards<br>N – Non-Safe System | Responsible Officer | |
|---|---|---|---|---|---|---|
| <p>2. Relocation of hydrant marker and blue reflector not completed. The design plan shows the hydrant marked at wrong end of Kent Road. The hydrant is outside number 130 in Kent Road. Any delay in updating these markings could cause the Fire Brigade a failure / delay to find the hydrant.</p> | Rare | Moderate | <p><b>Low</b></p> <p>Safe System energy within tolerable levels</p> | Consider installation of blue reflector and associated pavement markings (S) | Y | Hydrant markers and blue reflectors are the responsibility of Fire Rescue Victoria (FRV), not Councils or road authorities. Council will relocate the road marker (triangle) and has sent a works order for this to occur, and has notified FRV of the missing blue reflector for them to action. |

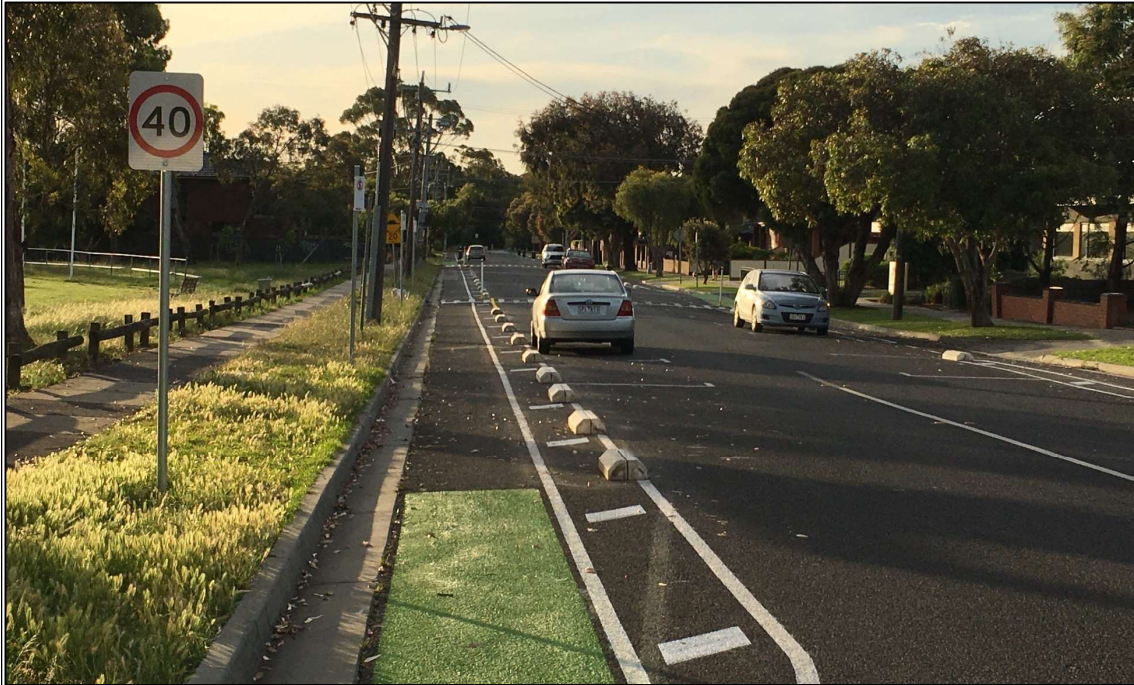
| Audit Findings | Risk Assessment | | | Recommendations<br><br>P – Primary<br>S – Supporting      ST – Step Towards<br>N – Non-Safe System | Responsible Officer | |
|---|---|---|---|---|---|---|
| <p>3. Speed sign (40 km/h) is erected at the Cumberland Road end of Kent Road but none exists on the Cornwall Road end. This could cause drivers to travel at unsafe speeds, increasing the risk of all crash types.</p> | Possible | Moderate | <b>High</b><br><br>Safe System<br>energy within<br>tolerable<br>levels | Consider installation of 40 km/h sign on Kent Road at west end. (S) | Y | Signs have been ordered and priority given to installation. |

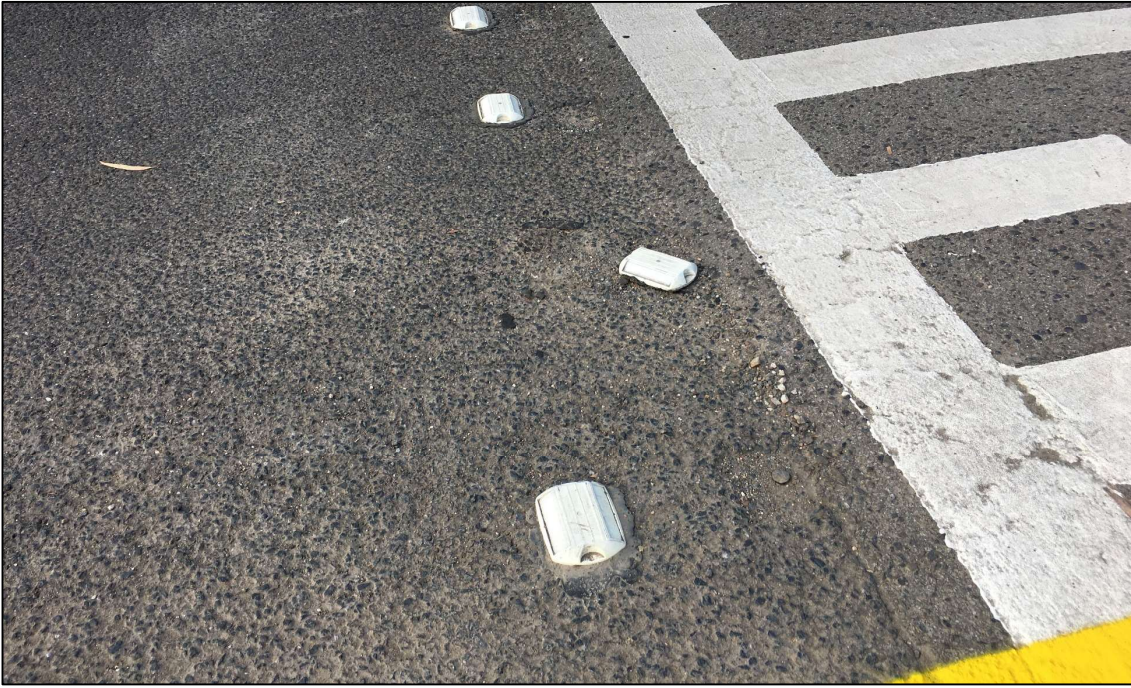
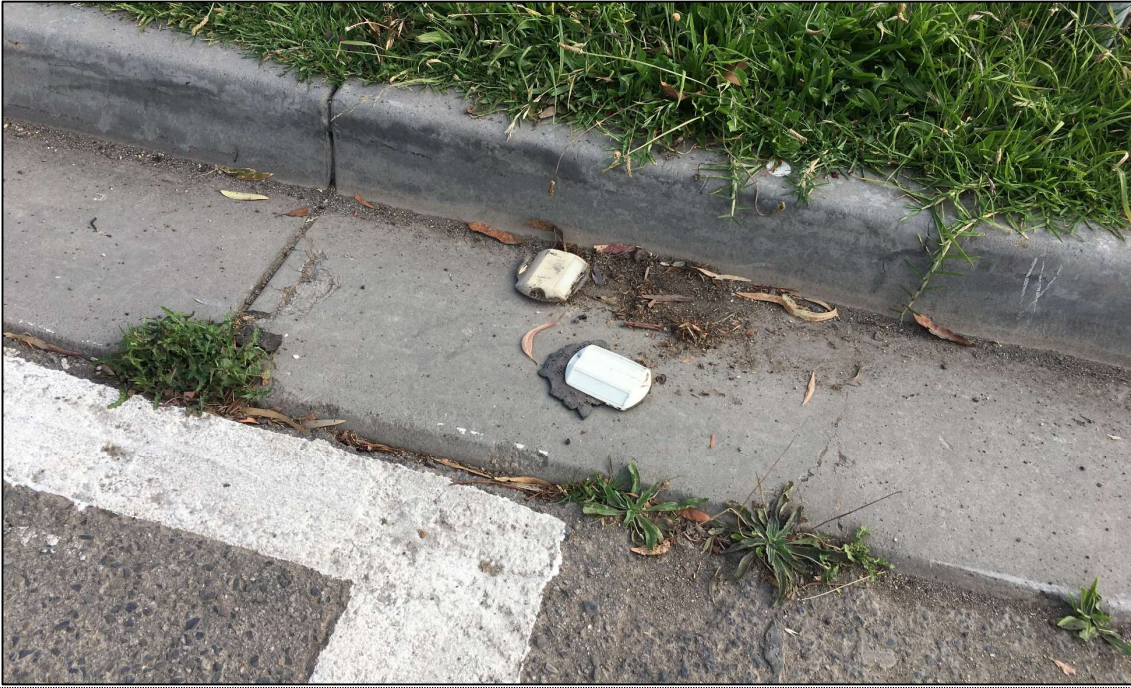
| Audit Findings | Risk Assessment | | | Recommendations | Responsible Officer | |
|---|---|---|---|---|---|---|
| <div>4. Reflective markers dislodging easily from pavement. The lack of reflective markers decreases the visibility of the speed hump at night.</div> <div> </div> | Rare | Moderate | <div>Low</div> <div>Safe System energy within tolerable levels</div> | Rectify and reinstate reflective markers (S) | Y | Have raised a works order as part of regular maintenance, and will continue to monitor during the trial. |

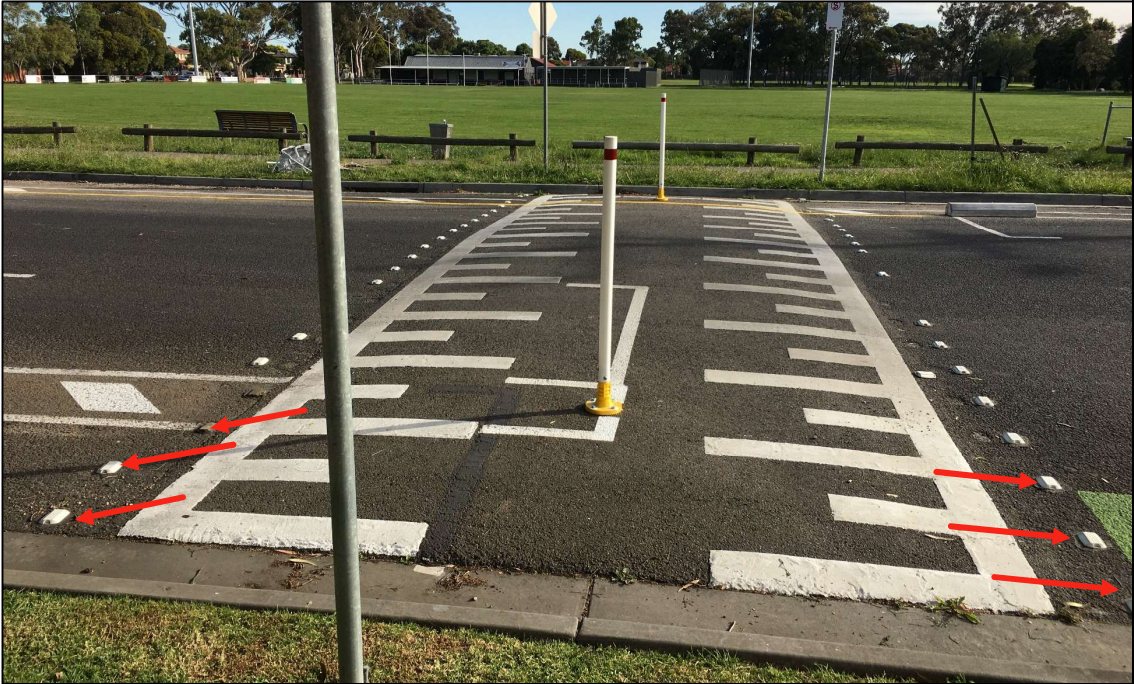
| Audit Findings | Risk Assessment | | | Recommendations<br><br>P – Primary<br>S – Supporting      ST – Step Towards<br>N – Non-Safe System | Responsible Officer | |
|---|---|---|---|---|---|---|
| <div>5. Reflective markers in bike lane area are hazardous to cyclists. The fixed and loose markers are a slipping hazard to cyclists, particularly when wet.</div> <div></div> | Rare | Minor | Negligible<br><br>Safe System<br>energy within<br>tolerable<br>levels | Consider removing reflective markers in the bike lane area only. (S) | Y | Works request submitted to Council depot to remove. |

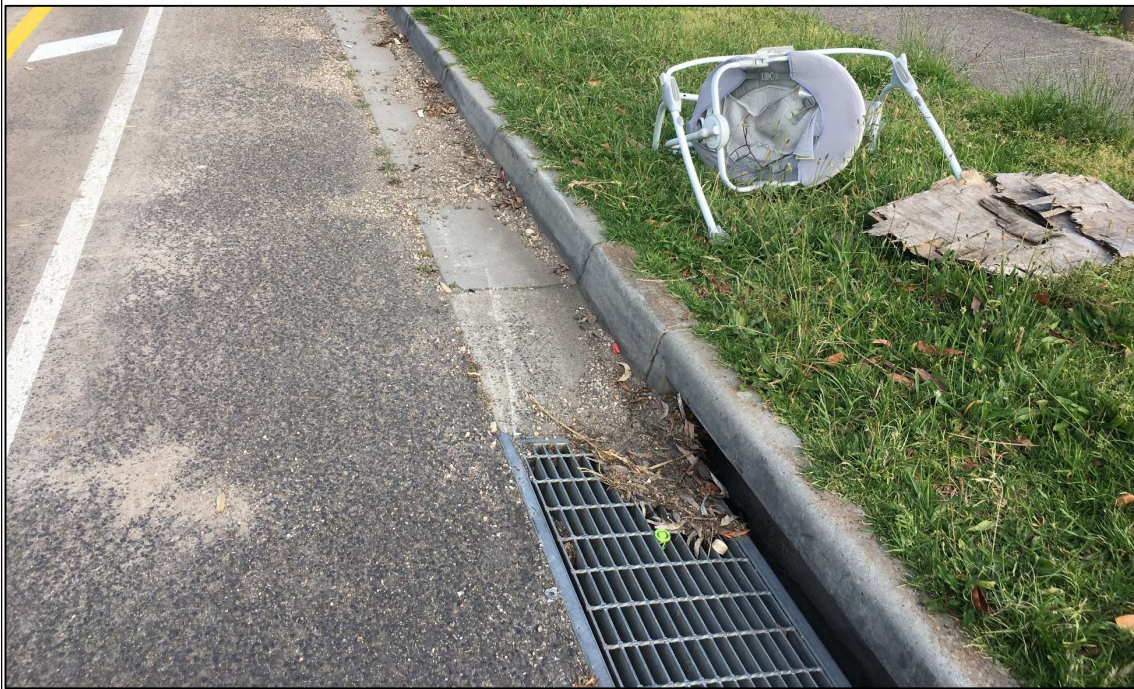
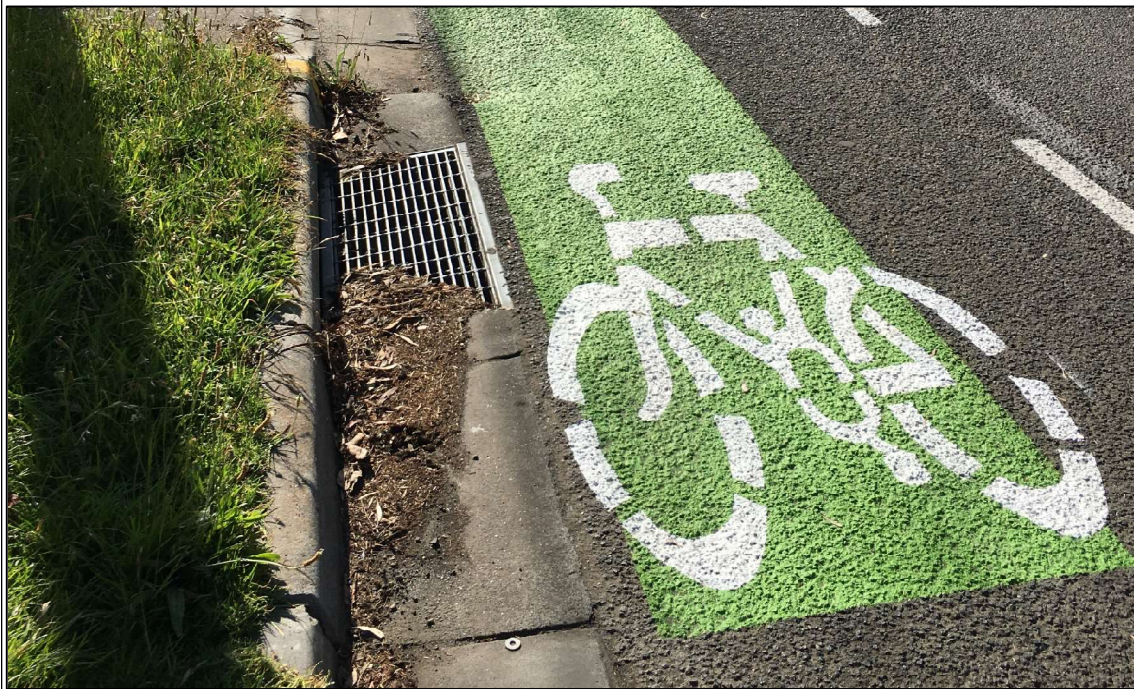
| Audit Findings | Risk Assessment | | | Recommendations<br><br>P – Primary<br>S – Supporting      ST – Step Towards<br>N – Non-Safe System | Responsible Officer | |
|---|---|---|---|---|---|---|
| <p>6. Bicycle lane needs cleaning on regular basis. Any build-up of rubbish or vegetation matter can be slippery to cyclists and increase the risk of a crash.</p> | N/A | N/A | To Note | Consider street sweeping of bike lanes. Add this cleaning process to regular maintenance schedule. (S) | Y | This bike lane is on Council's regular cleaning schedule. |

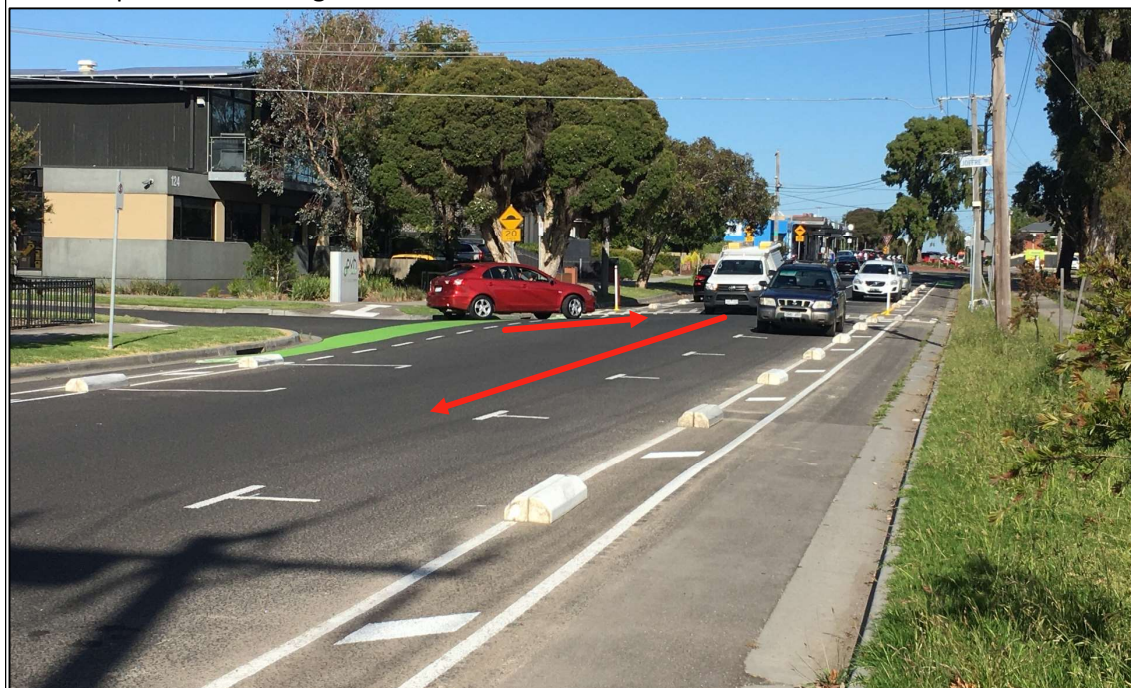
| Audit Findings | Risk Assessment | | | Recommendations<br><br>P – Primary<br>S – Supporting      ST – Step Towards<br>N – Non-Safe System | Responsible Officer | |
|---|---|---|---|---|---|---|
| <p>7. Sight lines are an issue when exiting Joffre Road. A lot of traffic is using the parking spaces in Kent Road and Joffre Road to attend the Medical Centre on the corner of Joffre Road. The Medical Centre has a car park for 9 vehicles and 1 disabled space. There are also 2 disabled park spaces on Joffre Road as well as 2 spaces for 5-minute parking. Users of this parking exit to Kent Road and turn left or right. In both directions there is parking along both sides of the road with single lane of traffic in the middle to cater for both directions. Exiting into Kent Road causes a clash with vehicles travelling along Kent Road. Vehicles can end up facing head on with other vehicles and cause a crash. The sight lines to view the traffic are difficult due to the parked cars along Kent Road.</p> | Possible | Moderate | High<br><br>Safe System<br>energy within<br>tolerable<br>levels | Consider: <ul style="list-style-type: none"><li>Monitoring of timed and disabled parking areas in Joffre Road. (S)</li><li>Changing 5-minute parking to be relevant during business hours (S)</li><li>Education of road users on new speed limits (S)</li><li>Education of road users on method of passing other traffic (S)</li></ul> | N | <p>Assessment of stopping sight distance as prescribed in the VicRoads Traffic Engineering Manual does not include parked vehicles, only fixed objects such as trees and poles.</p> <p>The speed limit on Kent Road has been reduced to 40km/h to improve safety at this intersection.</p> <p>The medical center has advised that they strongly prefer minimal impact to parking minimal impact to parking. The current parking is to the standard for all local roads.</p> <p>Will continue to monitor.</p> |

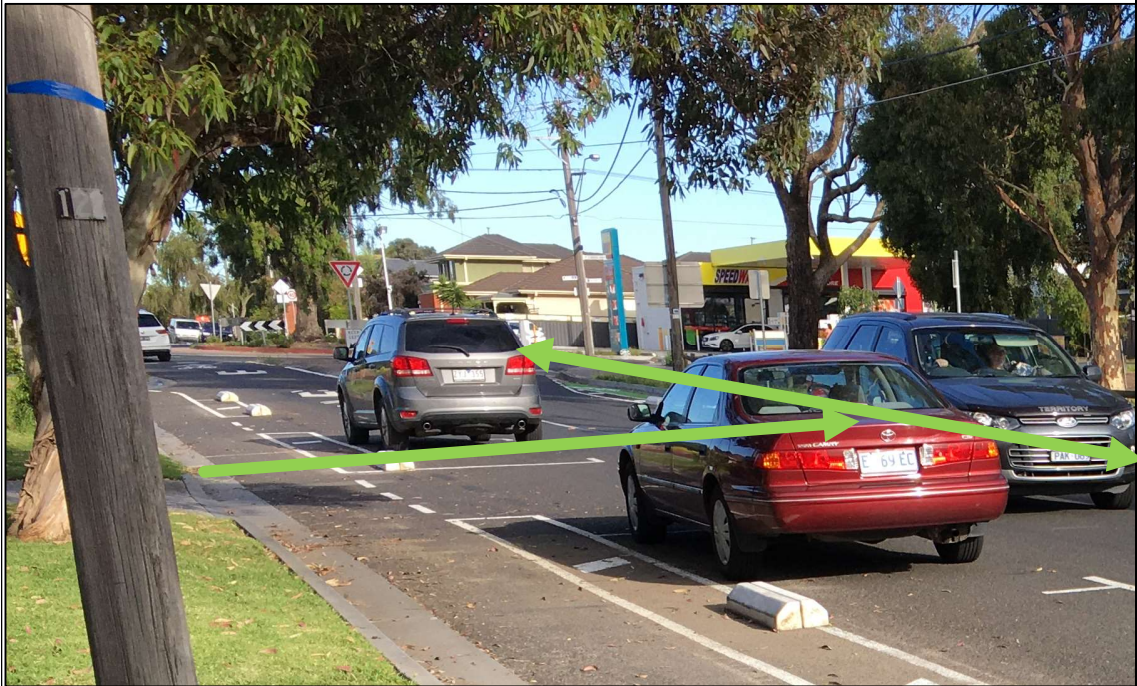
| Audit Findings | Risk Assessment | | | Recommendations<br><br>P – Primary<br>S – Supporting      ST – Step Towards<br>N – Non-Safe System | Responsible Officer | |
|---|---|---|---|---|---|---|
| <p>8. Sight lines when exiting private driveways. Similar to item 6 (above) particularly in vicinity of Joffre Road. Some residents mentioned that they are now reversing into their driveways so that they can drive out instead of reversing out onto this busy road.</p> | Possible | Moderate | <b>High</b><br><br>Safe System<br>energy within<br>tolerable<br>levels | Consider educational pamphlet for distribution to residents. (S) | N | <p>Drivers are making choices to improve safety along the roadway. Reversing into driveways is encouraged as it allows the driver greater visibility of bike riders, improving safety for all road users.</p> <p>Drivers need to make their own choices. Council does not agree to prepare a pamphlet.</p> |

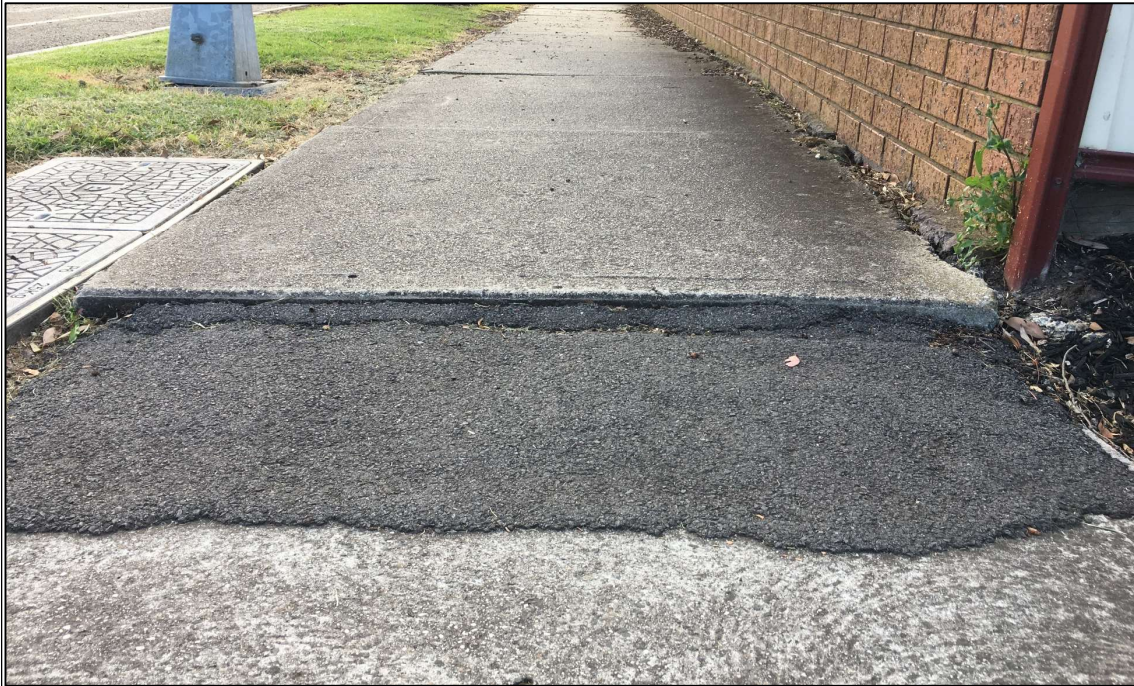
| Audit Findings | Risk Assessment | | | Recommendations<br><br>P – Primary<br>S – Supporting      ST – Step Towards<br>N – Non-Safe System | Responsible Officer | |
|---|---|---|---|---|---|---|
| <p>9. The footpath is damaged outside 128/130 Kent Road and increasing the risk of pedestrians tripping.</p> | Possible | Minor | Medium<br>Safe System energy within tolerable levels | Consider repair/replacement of footpath to consistent level. (S) | Y | <p>This was not part of the bike lane infrastructure, and is addressed as part of Council's Road Management Plan, which includes regular inspections and interventions.</p> <p>Officers have passed this finding onto the relevant area of Council. Will raise with the road maintenance team to inspect and address.</p> |

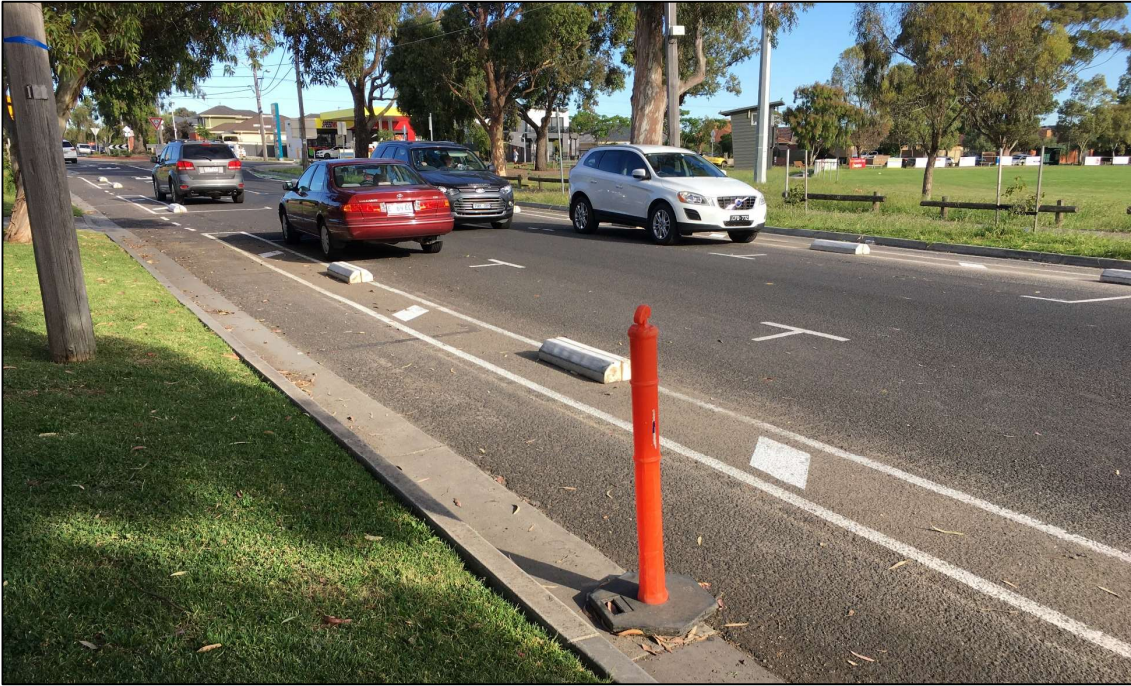
| Audit Findings | Risk Assessment | | | Recommendations<br><br>P – Primary<br>S – Supporting      ST – Step Towards<br>N – Non-Safe System | Responsible Officer | |
|---|---|---|---|---|---|---|
| <p>10. Bolted down concrete sections could cause tripping hazard for older people attending Medical centre. Residents mentioned that the Medical Centre attendees (particularly older ones) consider the bolt down concrete sections as a potential tripping hazard.</p> | Rare | Minor | Negligible | Consider the installation of flexible bollards on top of the concrete separators to improve the delineation of these items. (S) | Y | <p>Barriers are designed to match the current road environment, and the barriers have been installed with large gaps in between. Bolt-down kerbing can be stepped over similar to normal kerbing.</p> <p>Council does not agree with installation of flexible bollards on top of the separators, due to the visual impact. Instead, works have been ordered to paint the bolted down separators yellow, to increase visibility.</p> <p>Part of the Council resolution to extend the trial included the design and approval for a formal pedestrian crossing outside the medical centre, which will provide a designated and fully accessible crossing. Works on this are currently underway.</p> |

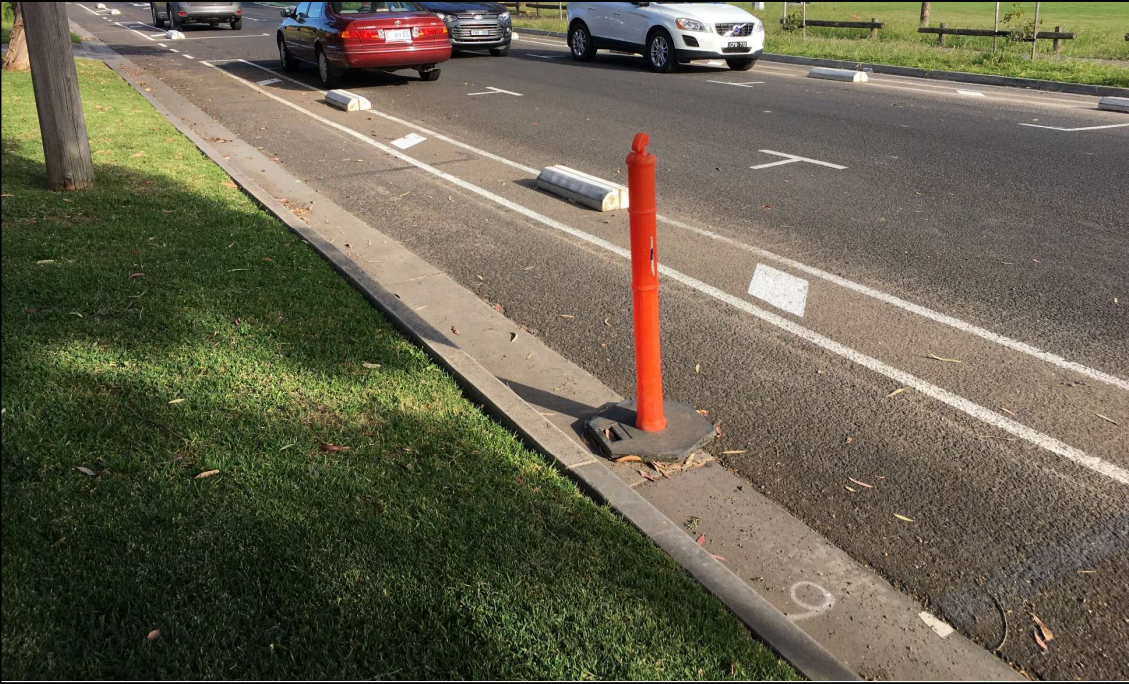
| Audit Findings | Risk Assessment | | | Recommendations<br><br>P – Primary<br>S – Supporting      ST – Step Towards<br>N – Non-Safe System | Responsible Officer | |
|---|---|---|---|---|---|---|
| 12. Construction bollard left behind<br><br> | N/A | N/A | To Note | Request removal when works are finished. (S) | | Has been removed. |
