MERRI-BEK GLASS COLLECTION POINTS: MONITORING & EVALUATION

31.10.2023

Cian Dreyer
Reground Pty Ltd
2 Wingrove Street
Alphington VIC 3078

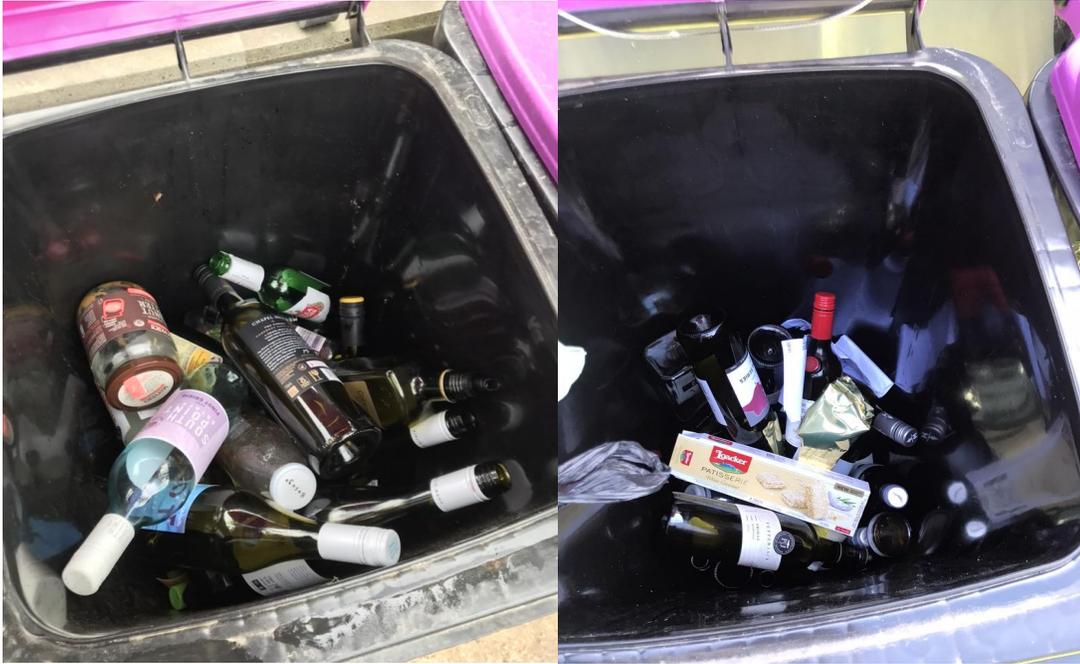
Image 3 (left) shows a bin without contamination; image 4 (right) shows moderate contamination.

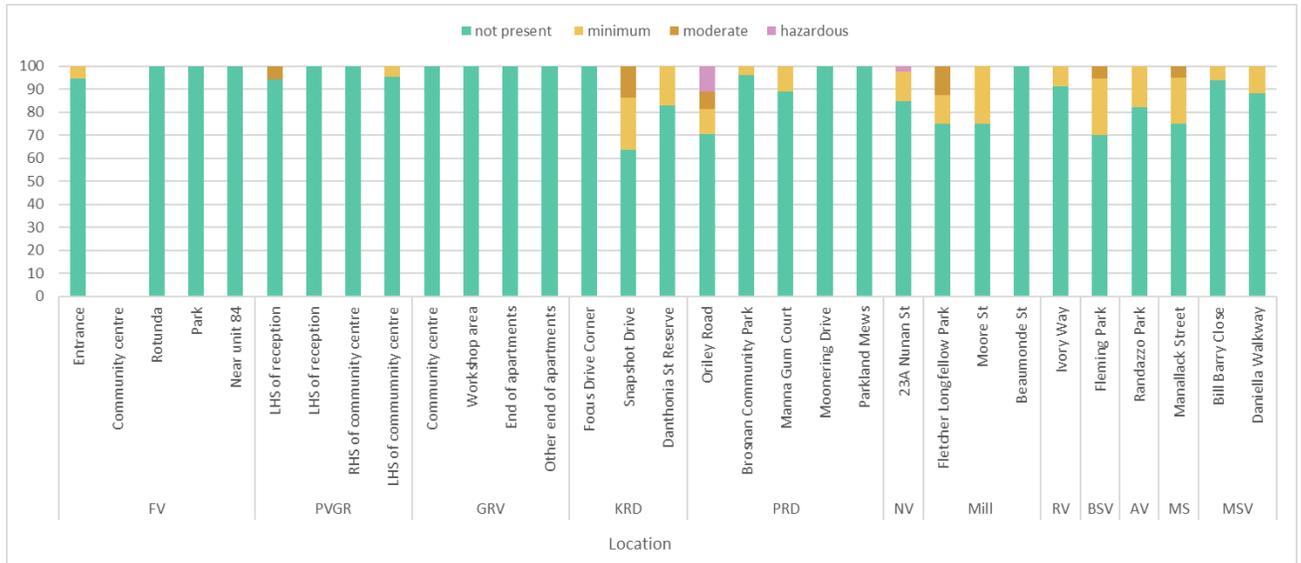
Figure 5: Percentage of contamination at each collection point across the ten weeks

Overall contamination rates were very low, with the outlying sites being Kodak Village: Snapshot Drive, Pentridge Village: Oriley Road, and Blythe Street Village: Fleming Park.

Based on the visual audit data, small steps to improve signage to further clarify correct bin usage could greatly reduce contamination rates. Signage should be updated to have images displaying common contaminate items, highlighting what cannot be placed in the bins. Examples of images to include: bagged glass recycling, commingled recycling, soft plastics (beer bottle wrapping) and broken glass. Could contain language encouraging to “put it in loose” or similar.

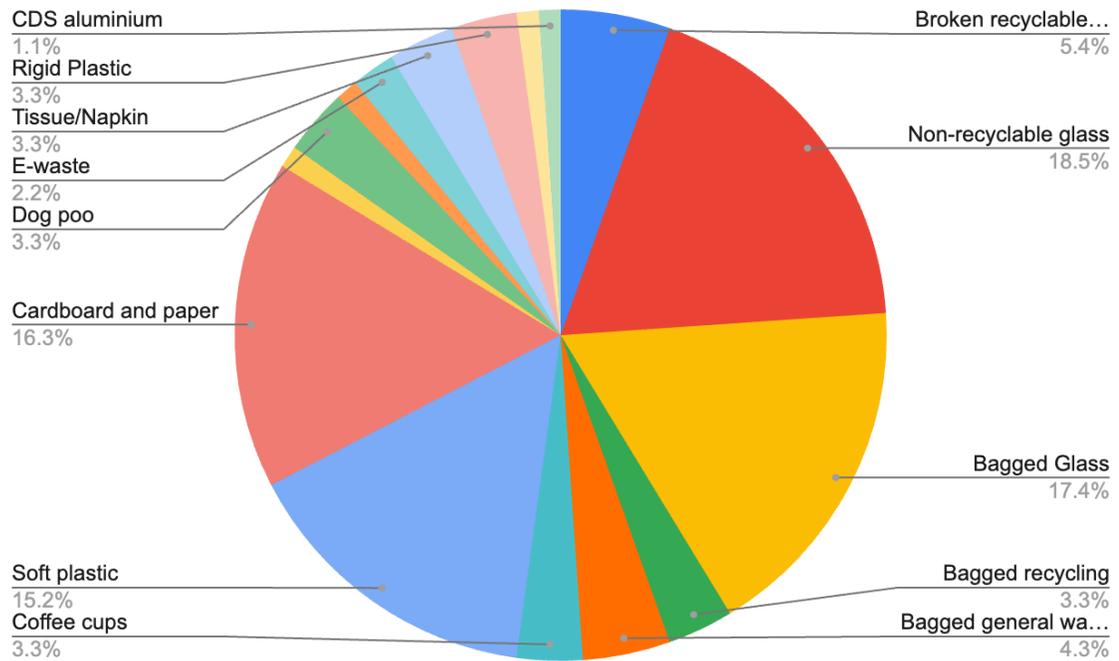
Figure 6: Profile breakdown of contamination items.

The majority of contaminants were non-recyclable glass (as defined by Merri-bek City Council's guidelines on the types of glass that cannot be recycled) followed closely by bagged recyclable glass and then boxes of cardboard or paper. Soft plastic contaminants were often seen in the form of beer bottle wrappings.
